## PYRITIC HEAVE IN IRELAND: THE ROLE OF PETROGRAPHY

Fred H. Shrimmer,  
Golder Associates, Vancouver Canada

Alan V. Bromley,  
Cornwall, UK

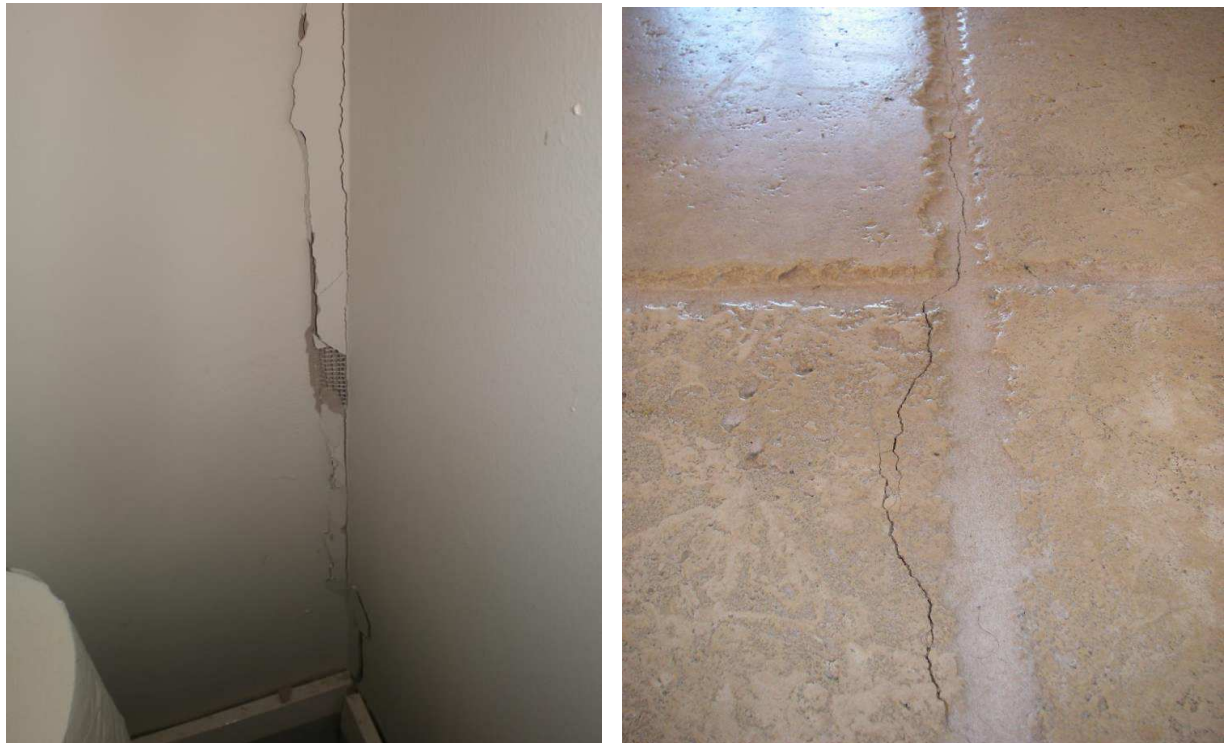
**Photograph 1: Typical damage observed in houses: cracks and bowed-out walls (left) and cracked heaved floor (right)**

Hundreds of claims were made by homeowners against their home insurance policies and numerous lawsuits were launched against both builders/developers as well as quarry operators/owners, to obtain compensation for the damages. Due to the progressive, cumulative and irreversible nature of pyritic heave, the only failsafe solution has consisted of the removal of the concrete floors, the excavation and disposal of the pyrite-bearing aggregate, the replacement with suitable fill, and the reinstatement of the slabs, along with cosmetic restoration of the properties. On average, the costs of undertaking this work ranged from €40,000 to 90,000 per residence/structure.

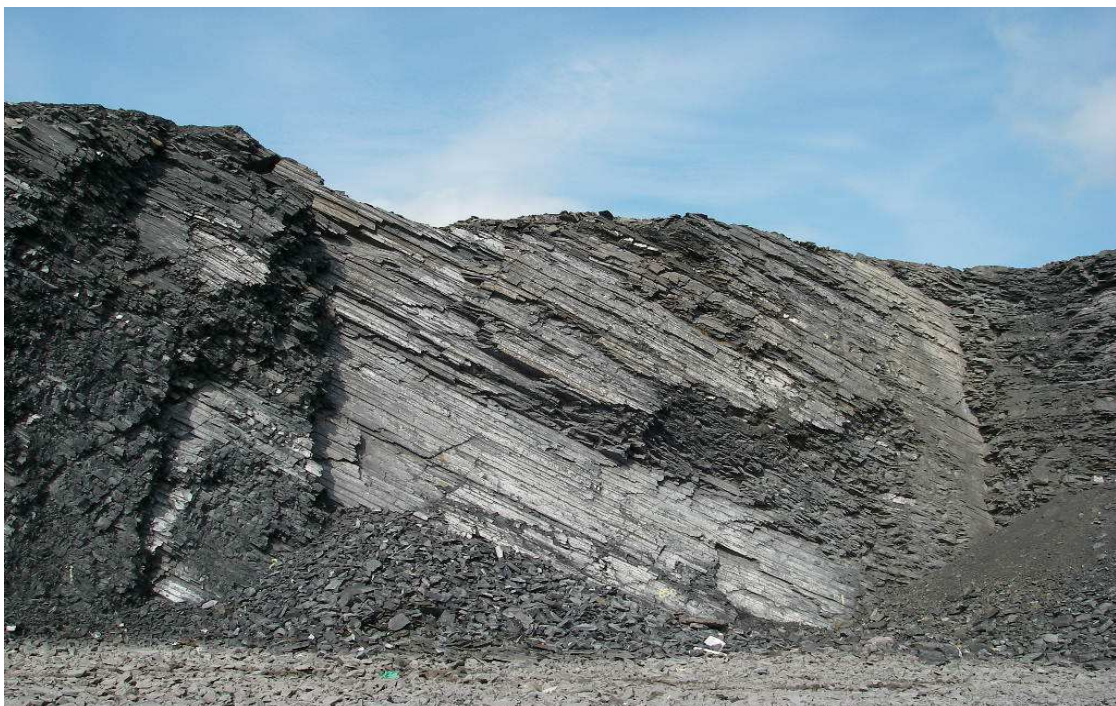
Photograph 2: View of quarry face, showing thinly bedded mudstone strata

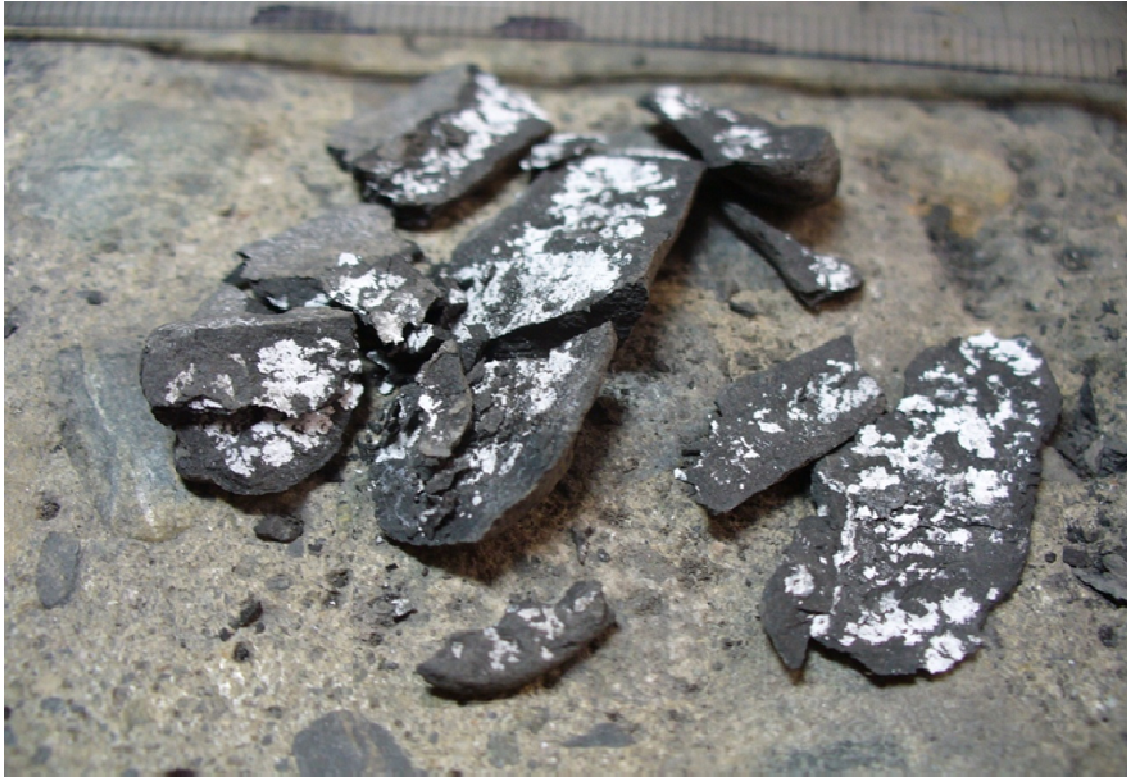
Secondary gypsum, aragonite and calcite were ubiquitous. They coated the surface of aggregate fragments and also grew along internal lamination planes.

**Photograph 3: Mudstone aggregate particles, after having been broken to expose interiors that contain numerous secondary gypsum deposits**

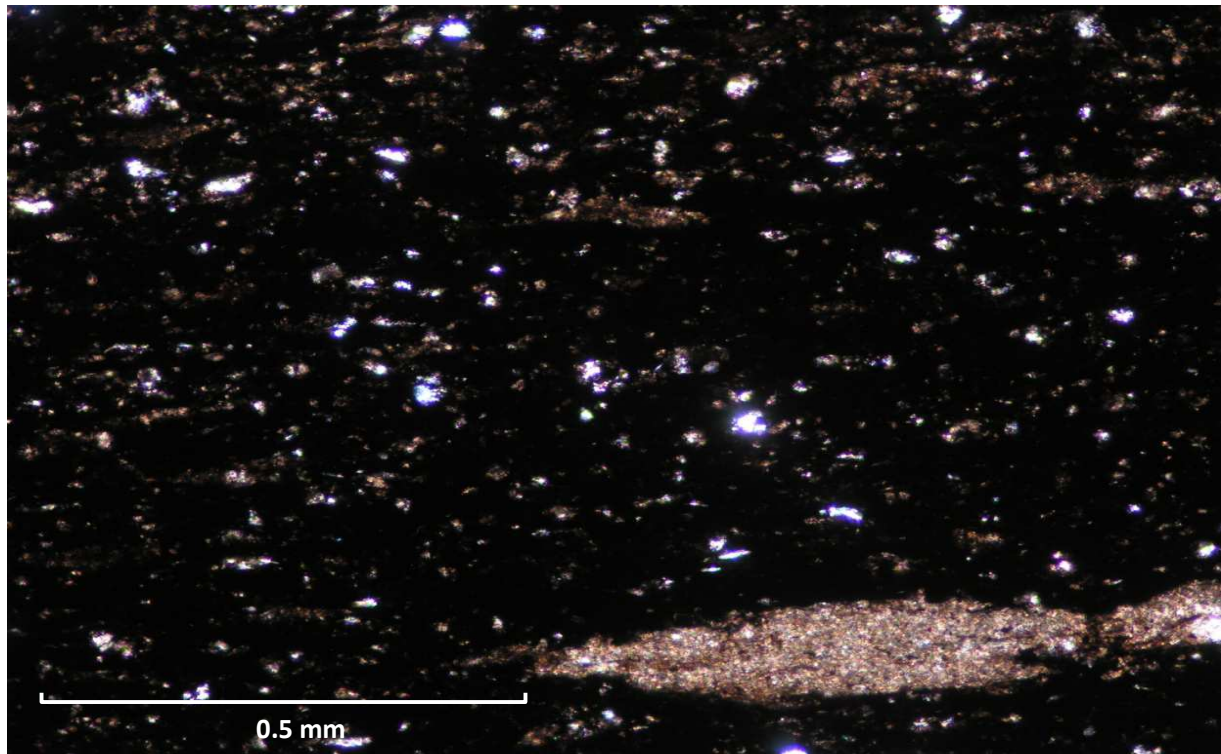
**Photograph 4:** Thin-section view in cross-polarized light: a dark and very fine-grained matrix, with detrital grains of quartz, calcite and feldspar

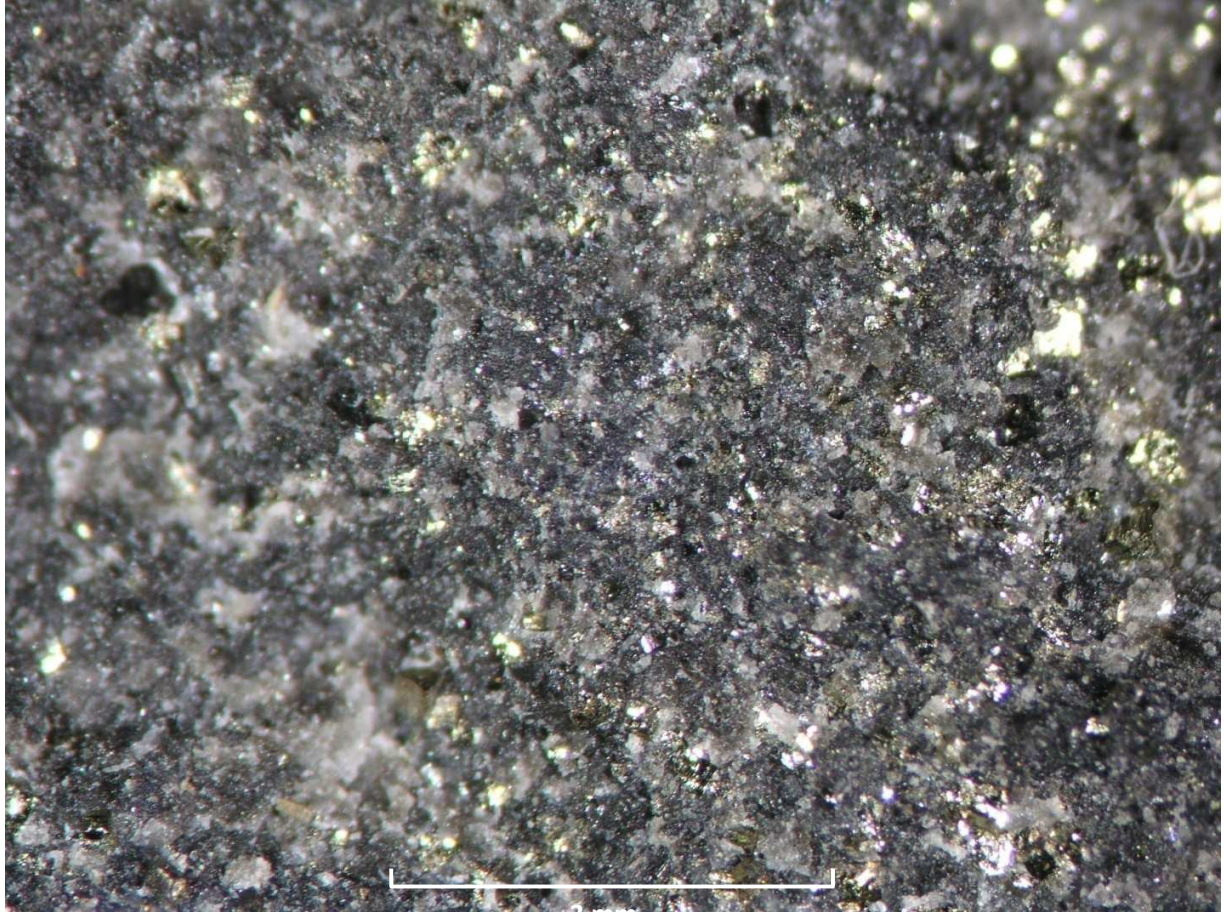
**Photograph 5: View of mudstone particle interior showing crystalline pyrite in a fine-grained matrix of clay- and silt-sized grains. Scale bar = 6 mm.**

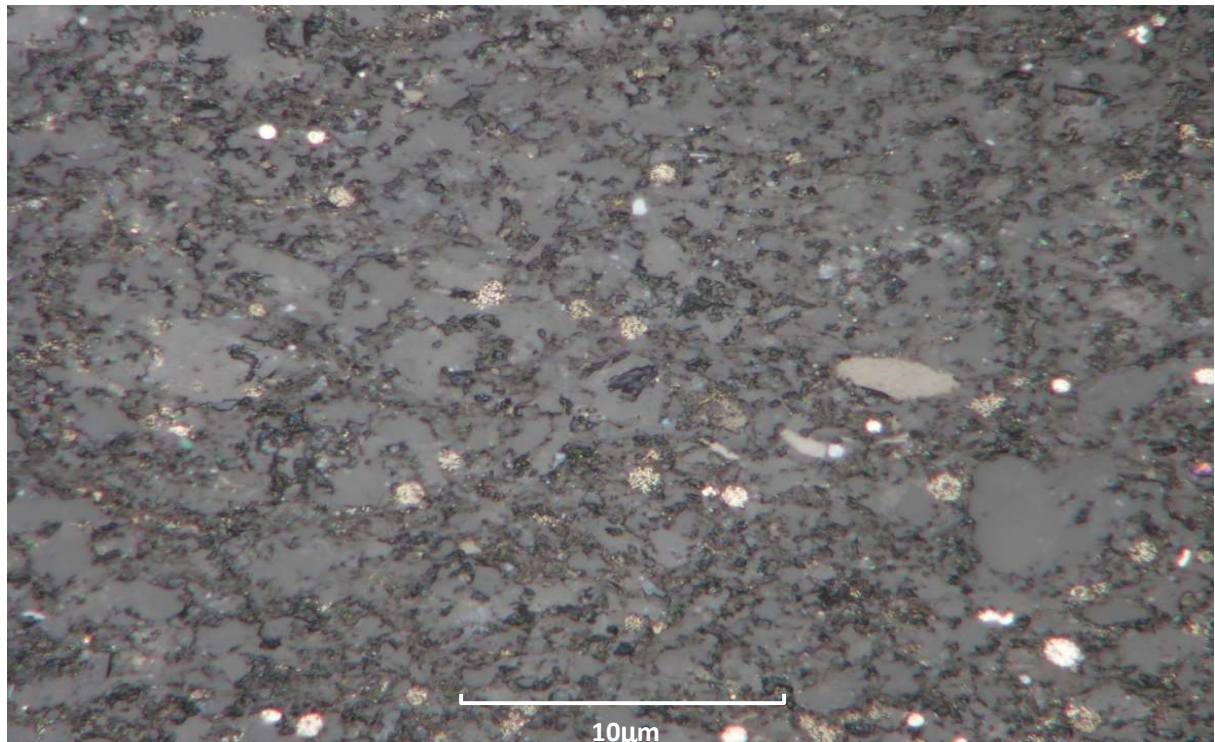
Photograph 6: View in reflected light of a thin-section of mudstone. Clusters of framboidal pyrite are observed.

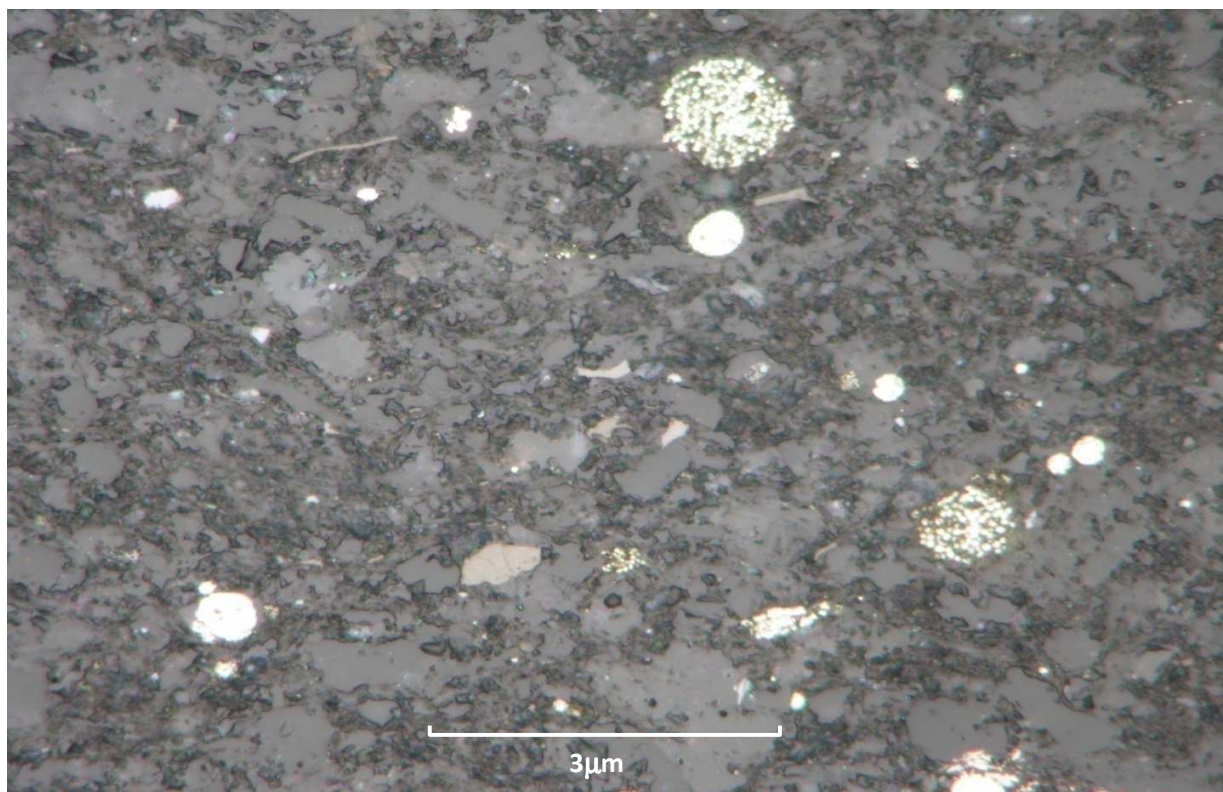
Photograph 7: Framboids of pyrite in mudstone

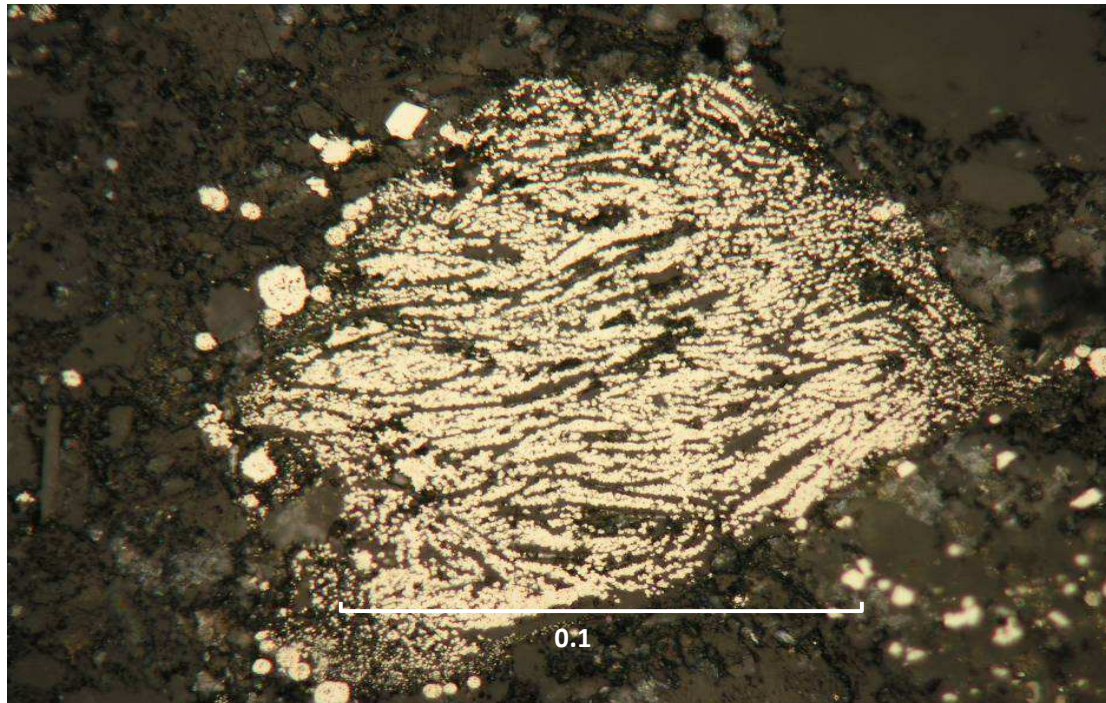
**Photograph 8: View of fine-grained and framboidal pyrite in mudstone**

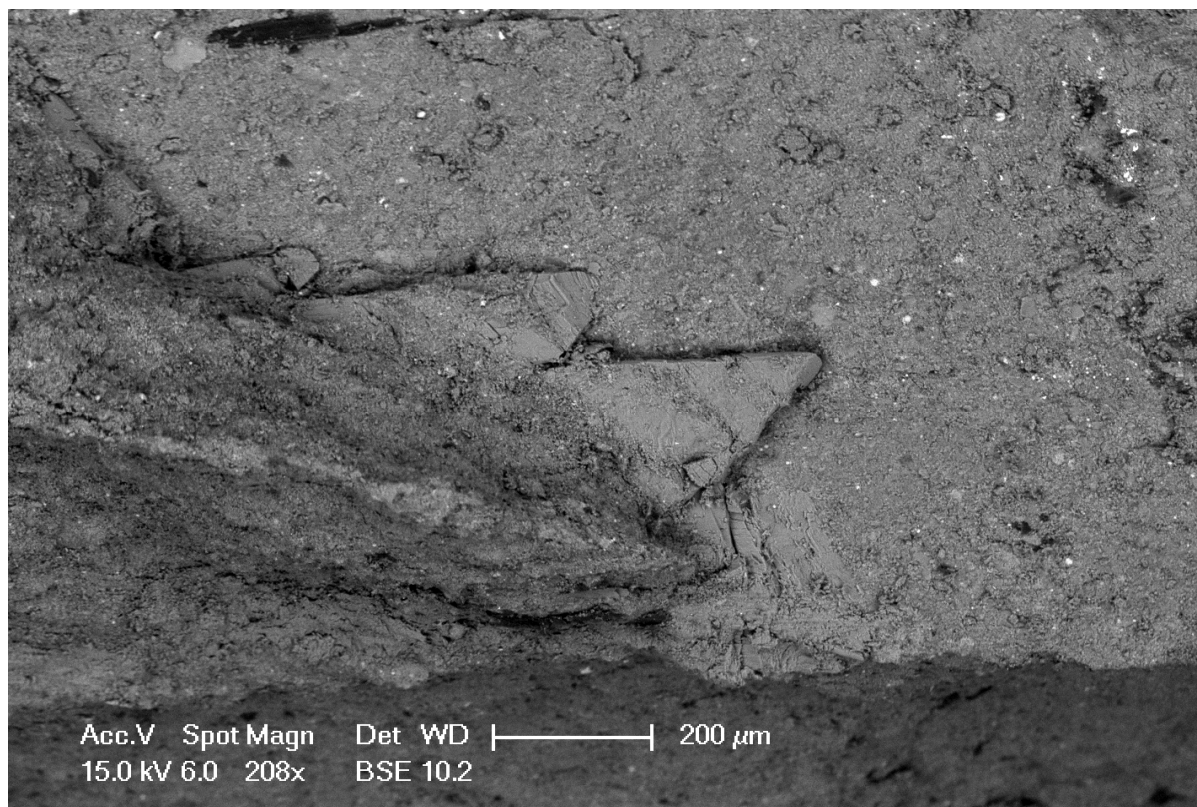
Photograph 9: Image from SEM of mudstone matrix with gypsum crystals seen centre and left portion of

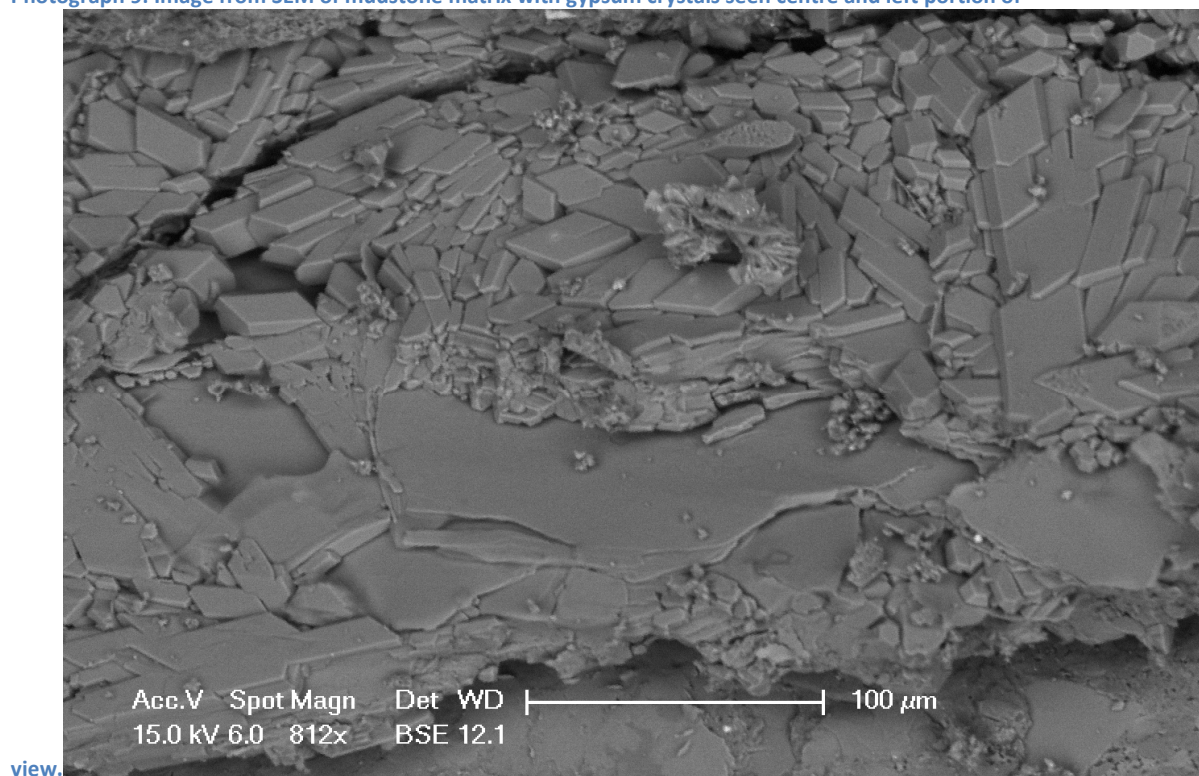
Photograph 10: Gypsum crystals seen on mudstone interior surface

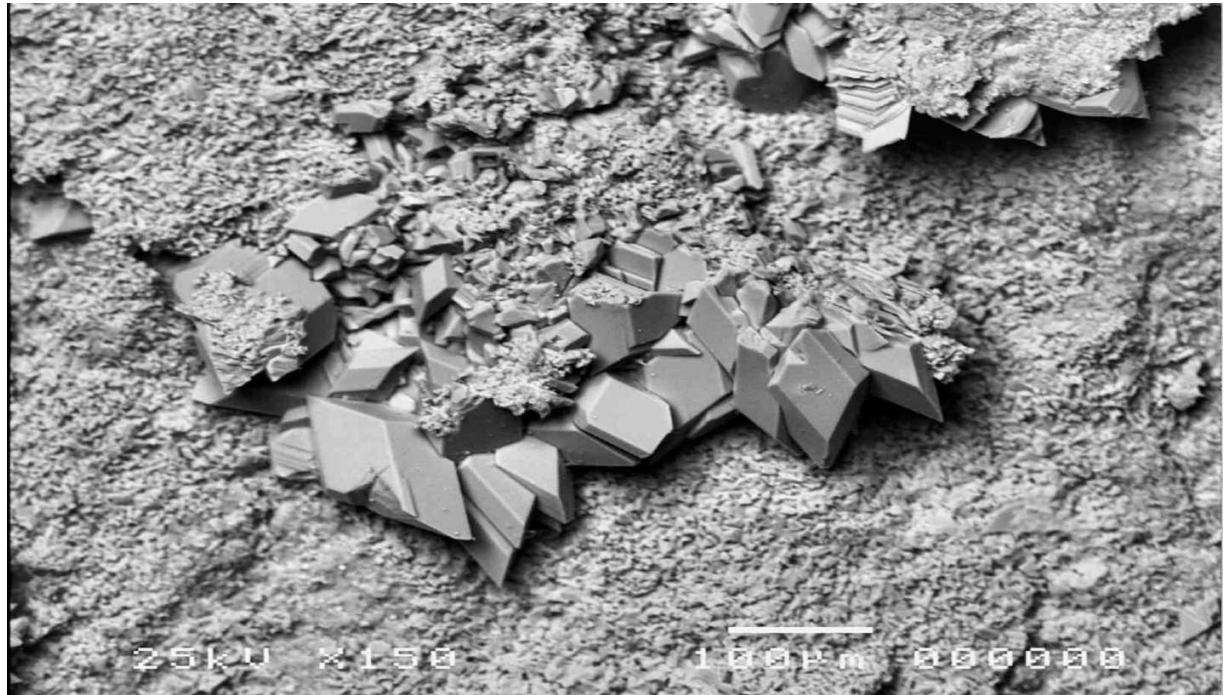
Photograph 11: Groups of gypsum crystals seen on a lamination surface of a mudstone particle.

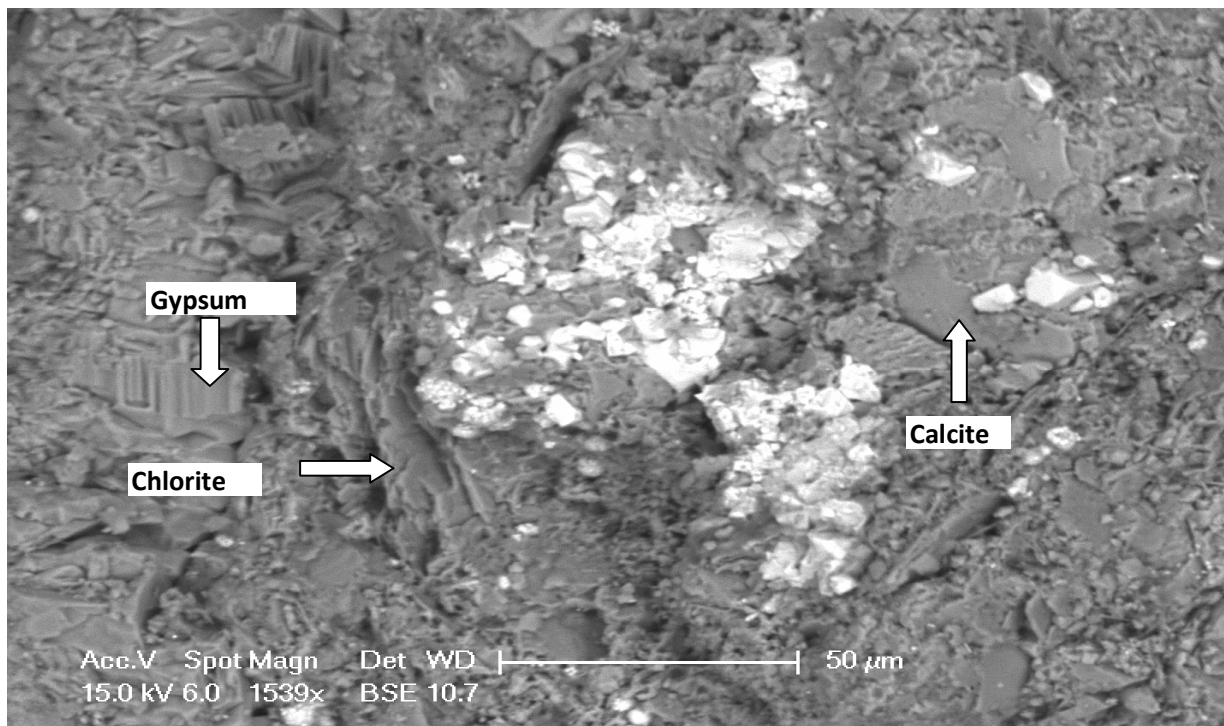
Photograph 12: Surface of a particle interior, showing pyrite (light coloured crystals) in the central portion of the image, adjacent to a vein of chlorite to the left, gypsum further to the left, and calcite to the right.

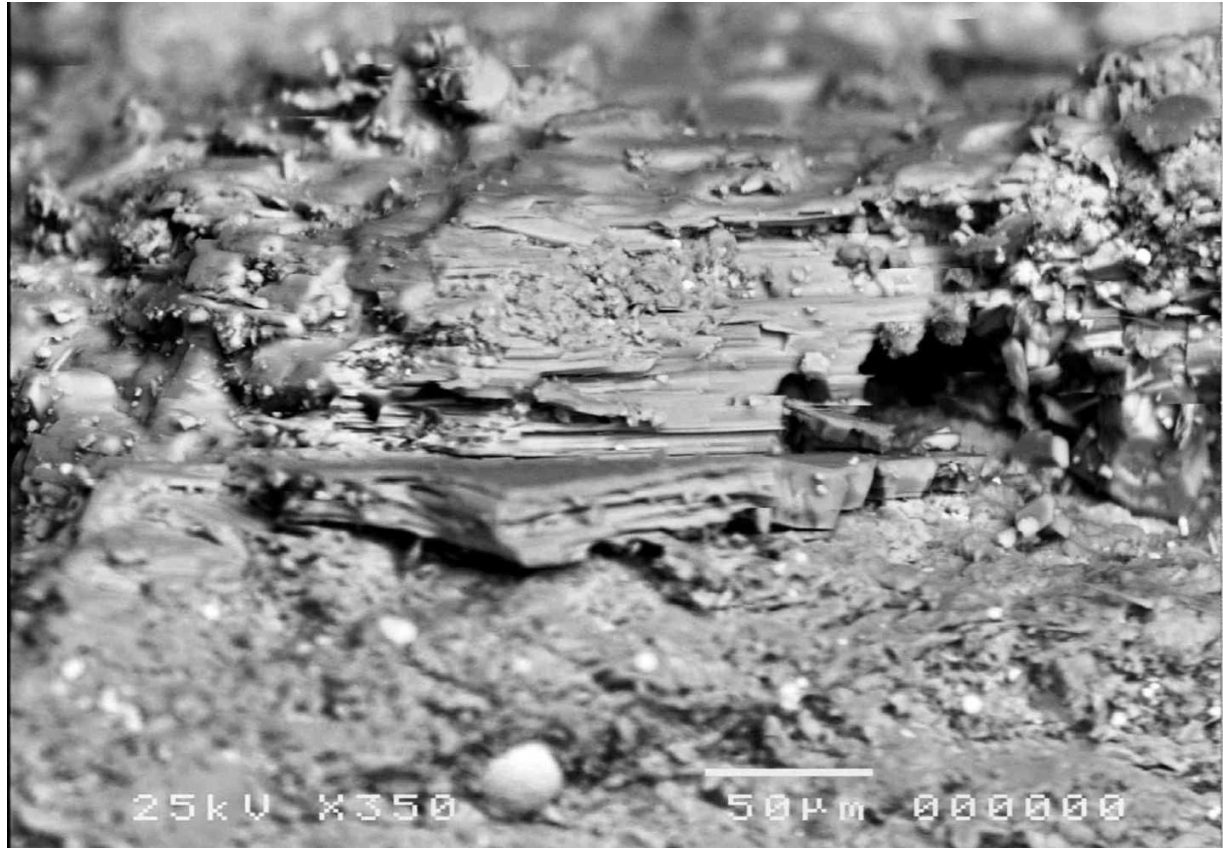
Photograph 13: Gypsum crystals and pyrite framboids in mudstone.

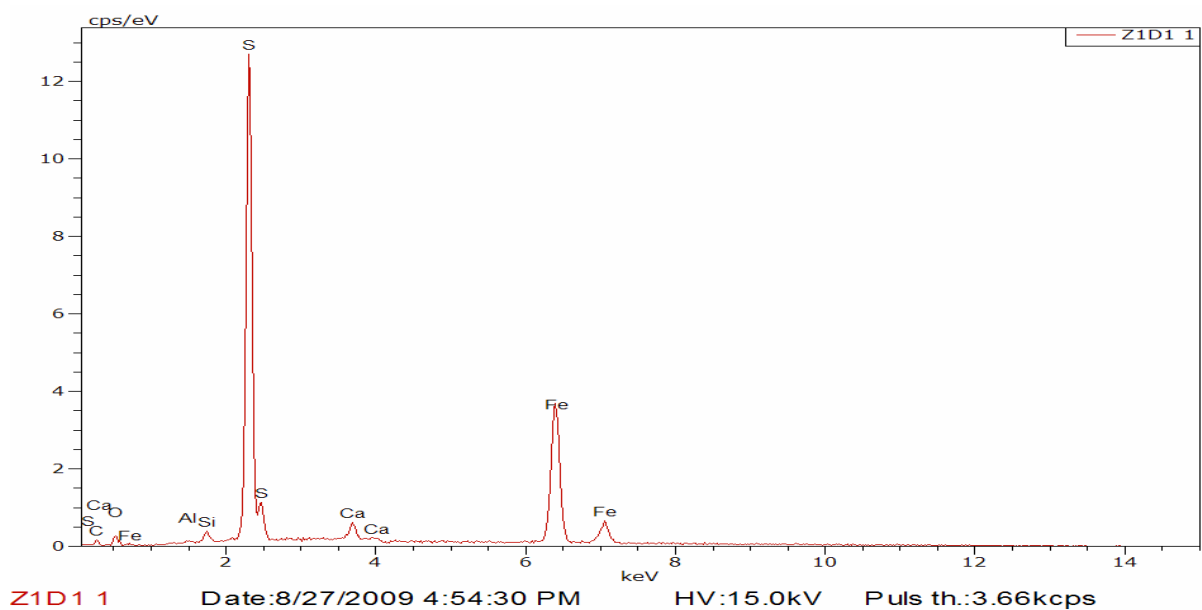
Figure 1 EDX scan of a crystal observed in the SEM examination, illustrating strong peaks for Sulphur and Iron, consistent with pyrite's composition

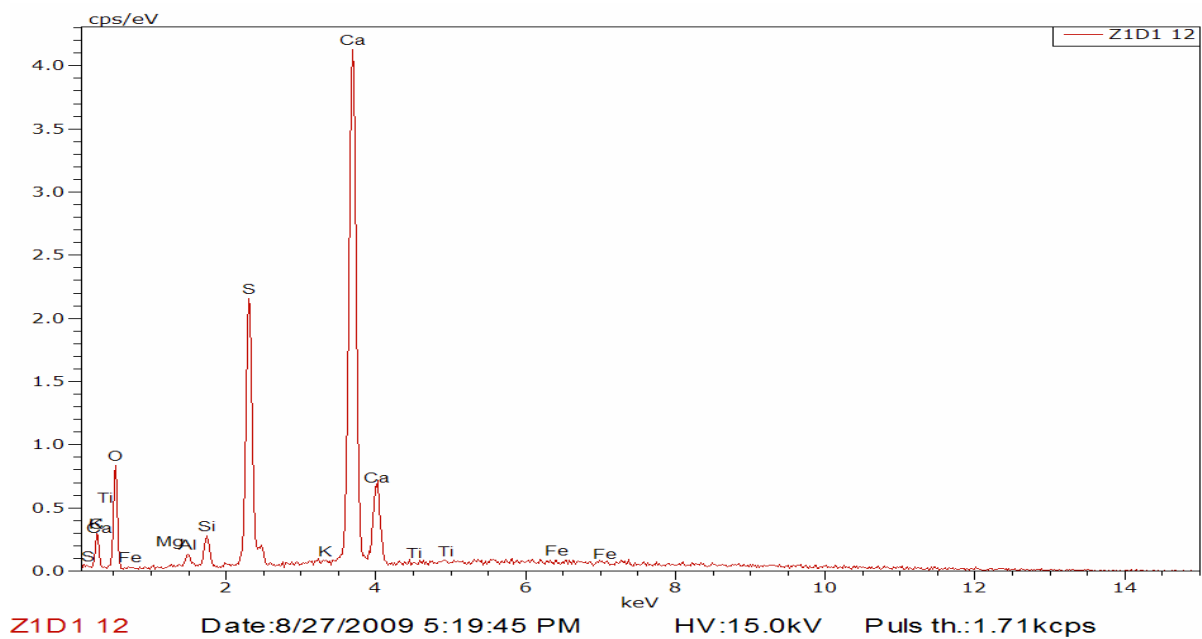
Figure 2: Strong peaks for Calcium, Sulphur and Oxygen indicative of Gypsum

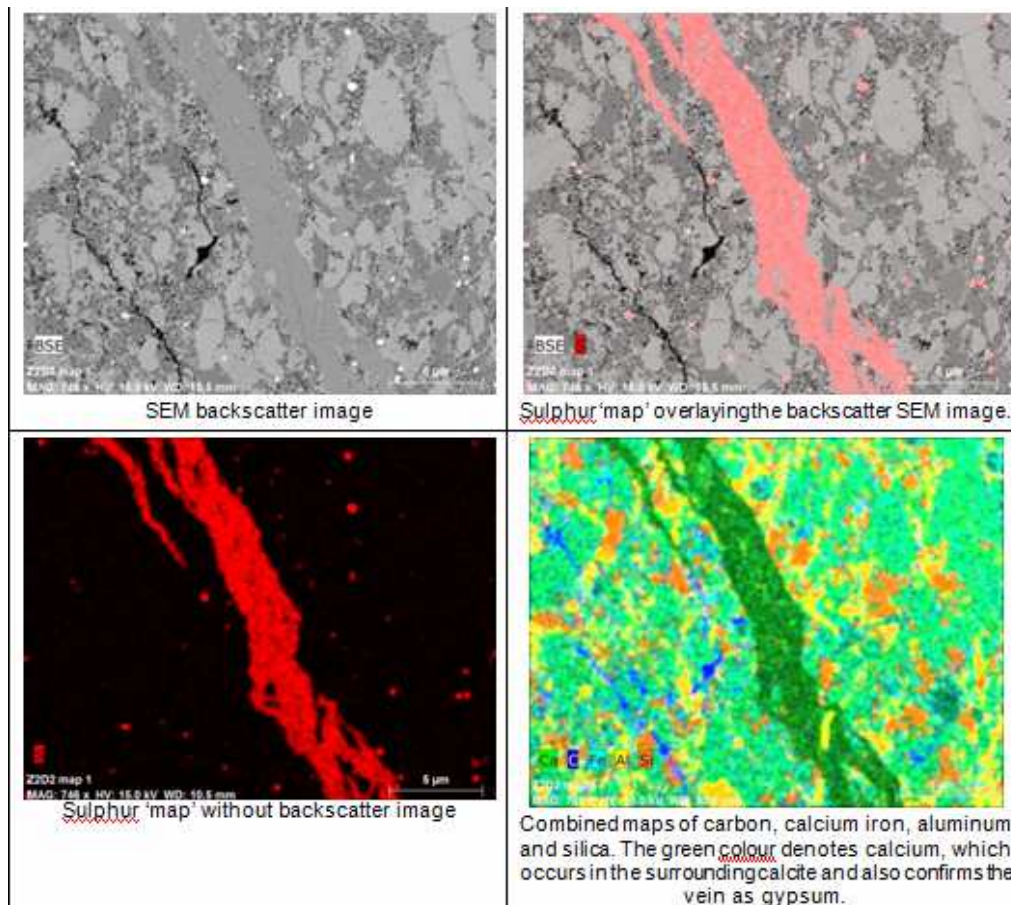
Digital element mapping was used to illustrate the distribution of various phases in the altered aggregate. Figure 16 clearly shows a vein of gypsum (high Ca + S) in calcareous mudstone with principal components (Ca, Si, Al and Fe) contained in calcite, quartz, clay minerals and chlorite.

Figure 3: Imagery from element mapping of a portion of a mudstone particle, confirming the presence of gypsum in a vein.

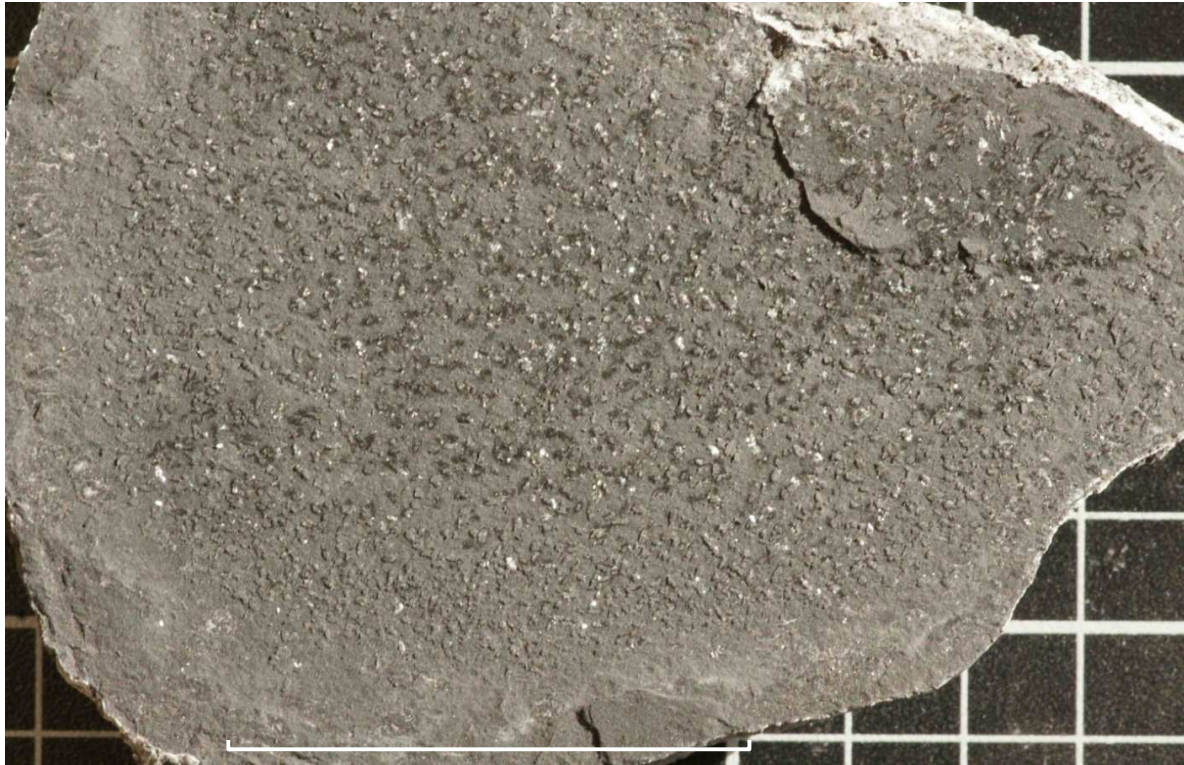
Photograph 14: Abundance of gypsum crystals on an opened lamination plane within a mudstone particle. Scale bar = 4 mm

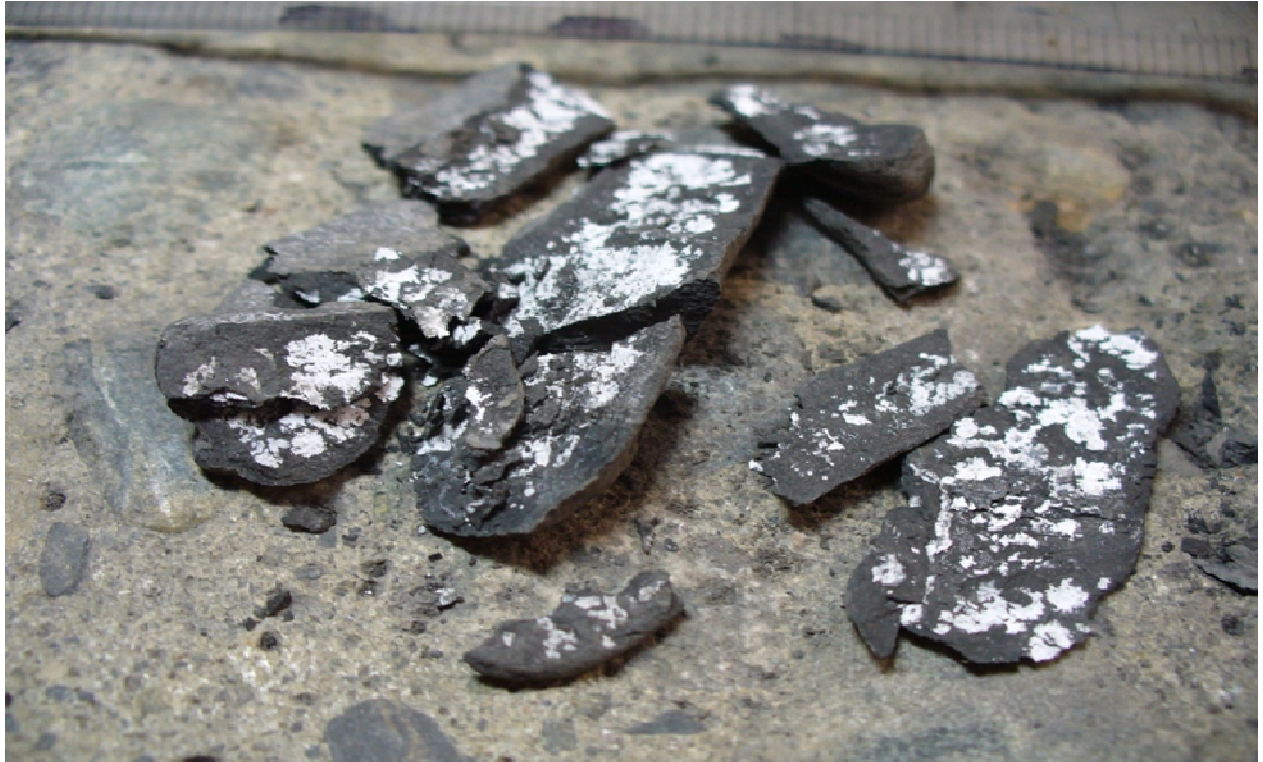
**Photograph 15: Fragmented mudstone aggregate particle, illustrating the abundance of secondary gypsum crystal growth within the laminations of the rock.**

considerable period of time, and thus, it was thought that the only sure means to deal with the problem was to remove the fill and replace it.

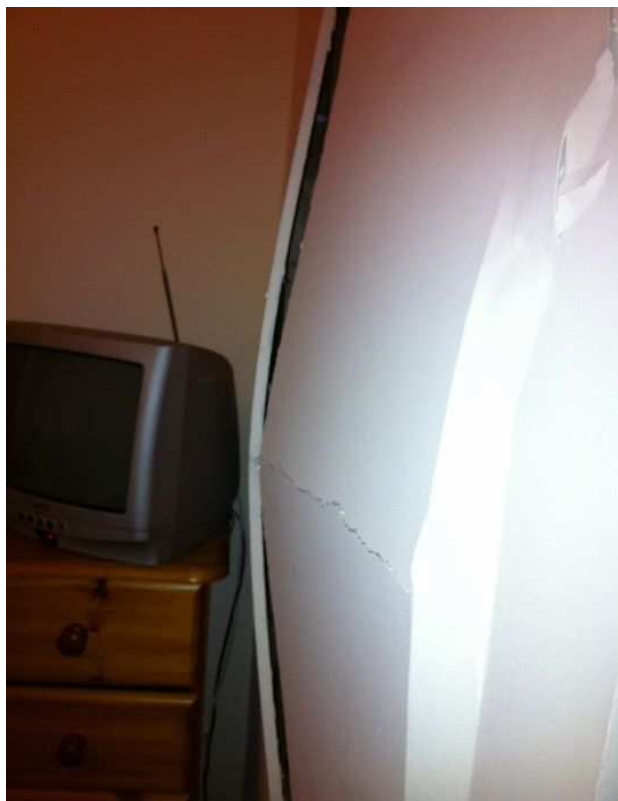
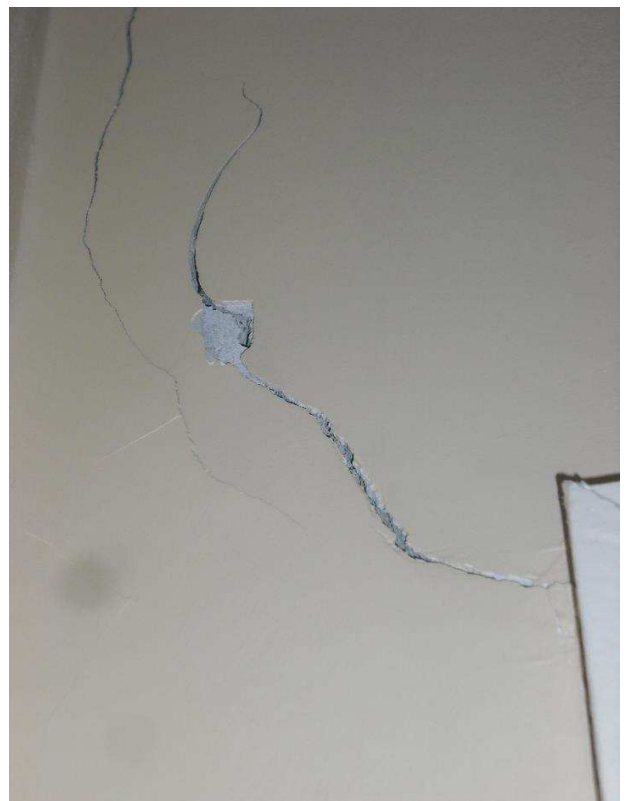
Photograph 16: Bulging out distortion of walls, and cracking at door frames.

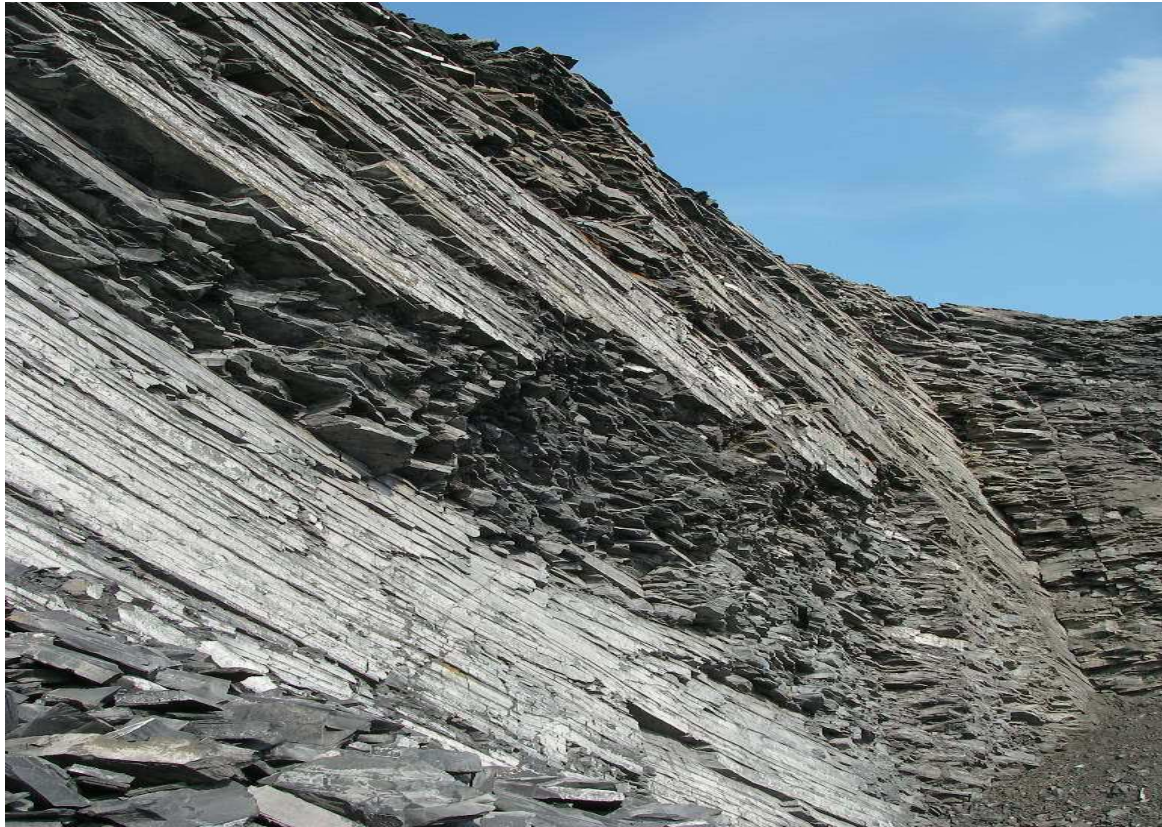
Photograph 17: View of a portion of north quarry face, showing laminated structure of mudstone.

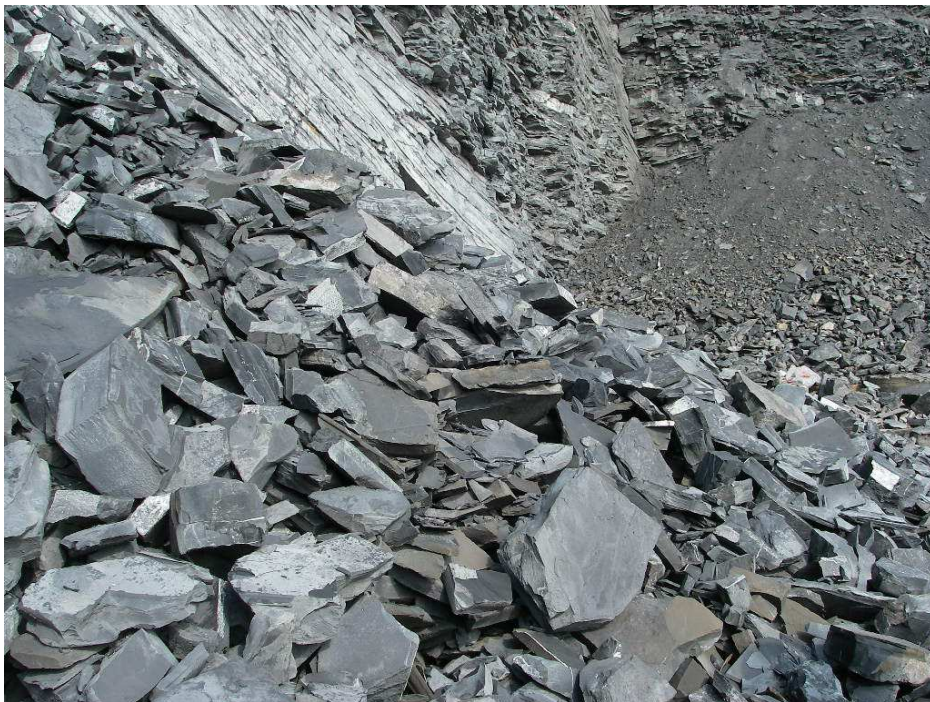
Photograph 18: View of blast rock accumulation at foot of quarry face.

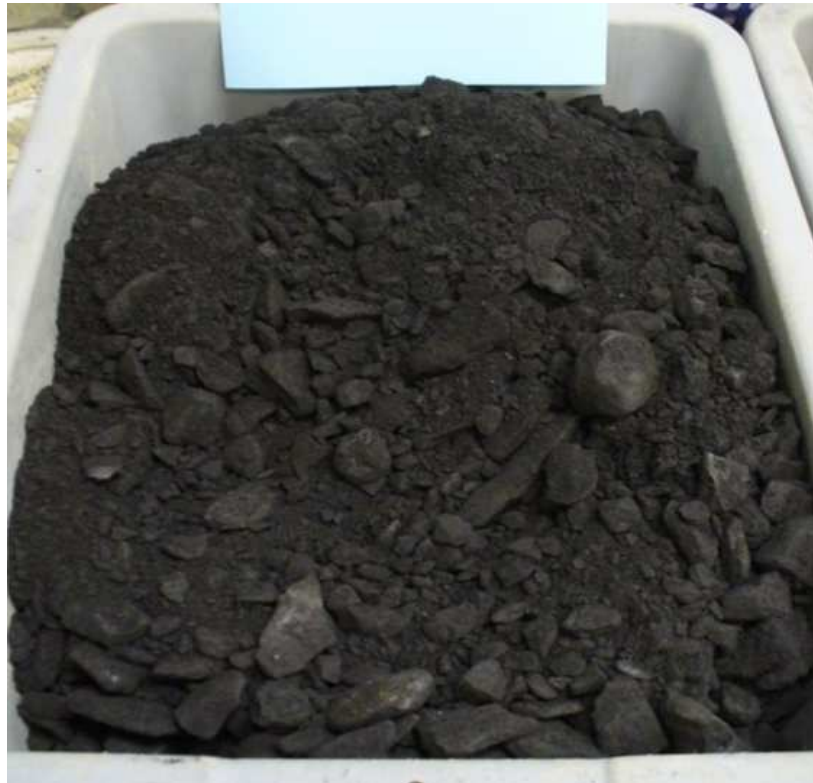
Photograph 20: Sample of mudstone aggregate as-received from subfloor investigation site. FOV about 30 cm.

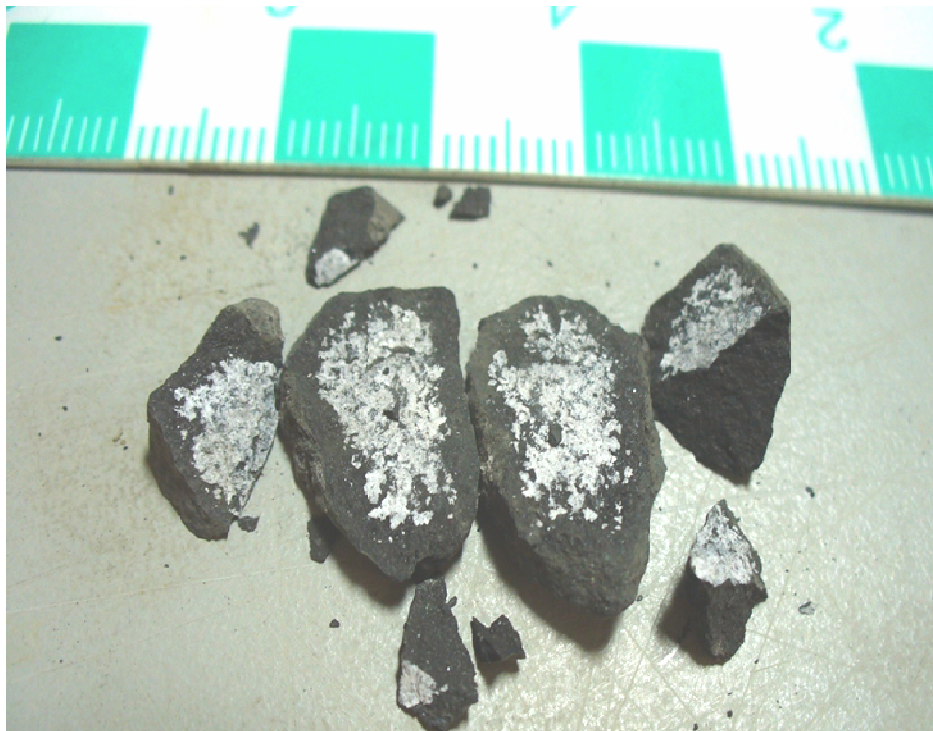
Photograph 19: Mudstone particle split open on a lamination, exhibiting secondary gypsum crystal growth. FOV about 150 mm
