Petroab Ltd, C Edwards Offices, Gweal Pawl, Redruth, Cornwall TR15 3AE, United Kingdom

A compendium of concrete aggregates used in Southwest England

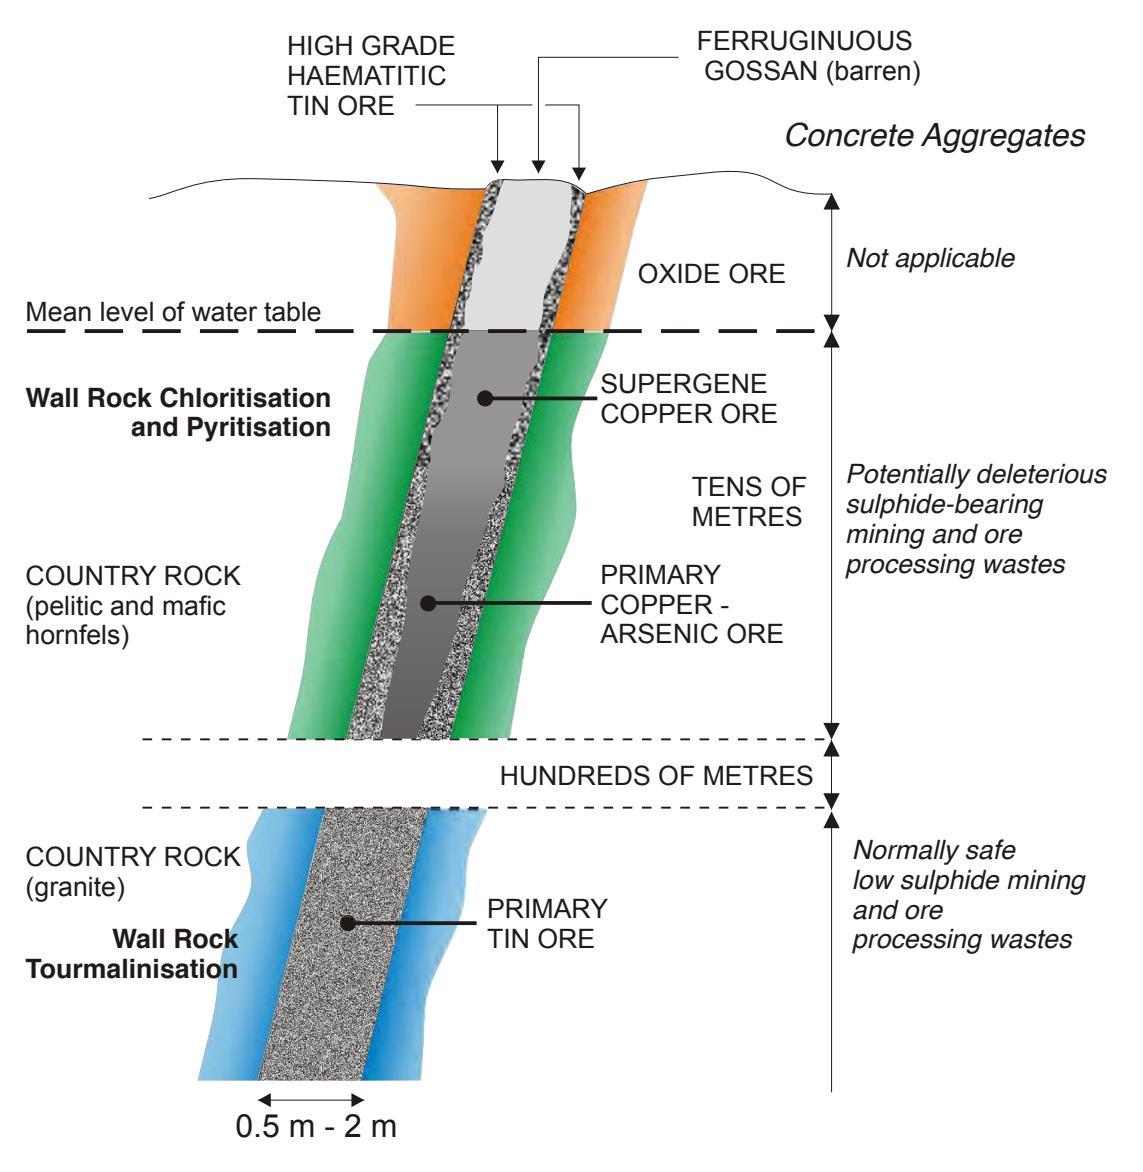
Figure 1-2. An idealised cross section through a high temperature tin - copper - arsenic lode like those in the Camborne - Redruth - St Day mineralised district. The lodes are vertically zoned with sulphide-deficient tin mineralisation at depth and sulphide-rich copper and arsenic mineralisation at higher levels. Lodes are generally narrow so the miners were often forced to extract altered wall rock and even unaltered country rock in addition to the vein material itself. Mining and processing wastes are necessarily complicated, consisting of veinstones, altered wall rock (often with disseminated sulphides) and unaltered host rocks.

minerals, in veins and altered wallrock (figure 1-2). Fine-grained and potentially very reactive sulphide minerals were not recovered before the introduction of flotation separation techniques in the early part of the twentieth century. In the eighteenth and nineteenth centuries rich copper ores, with coarse chalcopyrite, were often broken by hand and sorted before grinding and further benefication. The waste, typically with 50mm - 100mm top size, contained some residual chalcopyrite and other sulphide minerals including pyrite and arsenopyrite. Hand-cobbed copper wastes were used as aggregate in low fines mass concrete in the Camborne - Redruth district. Poor construction and high sulphide mineral content have sometimes led to very serious degradation.

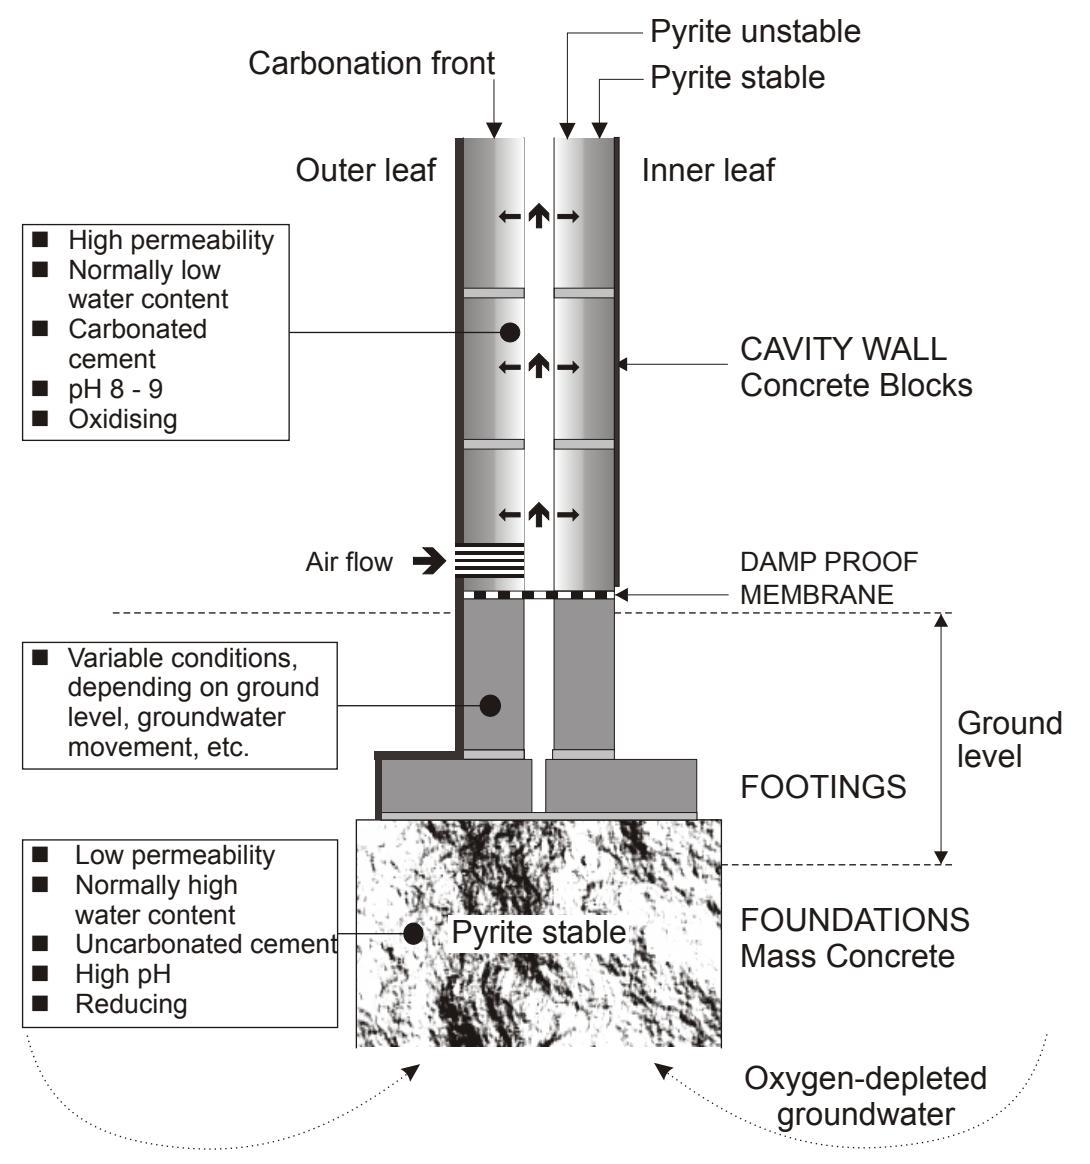
An idealised section through the foundation and wall of a typical domestic property is shown in figure 2-1. There are many variations, particularly in older houses, such as absence of a damp proof membrane or solid walls built with mass concrete or concrete blocks.

Figure 2-1. Physiochemical conditions in foundations and walls.

Physiochemical conditions are strongly contrasted in different structural elements (figure 2-1). The pH of pore fluids in concrete with uncarbonated cement is > 12.5. When the cement is fully carbonated it falls to about 8.5. Mass concrete used in foundations and even in some walls, has cement:aggregate ratios and macroscopic pore volumes comparable to those of modern structural concrete. Carbonation depth is often only a few millimetres, even after many years. Foundation concrete is often saturated with groundwater from which oxygen has been removed by reaction with Fe(II) minerals and organic matter in soil. Pyrite in wet mass concrete foundations usually shows only superficial oxidation. The stability of pyrite in contact with uncarbonated cement paste may be a result of oxygen depletion or build up of a layer of oxidation products that are insoluble under alkaline conditions, effectively rendering the pyrite passive (figures 2-2, 2-3). Additionally, it is possible that pyrite oxidation is

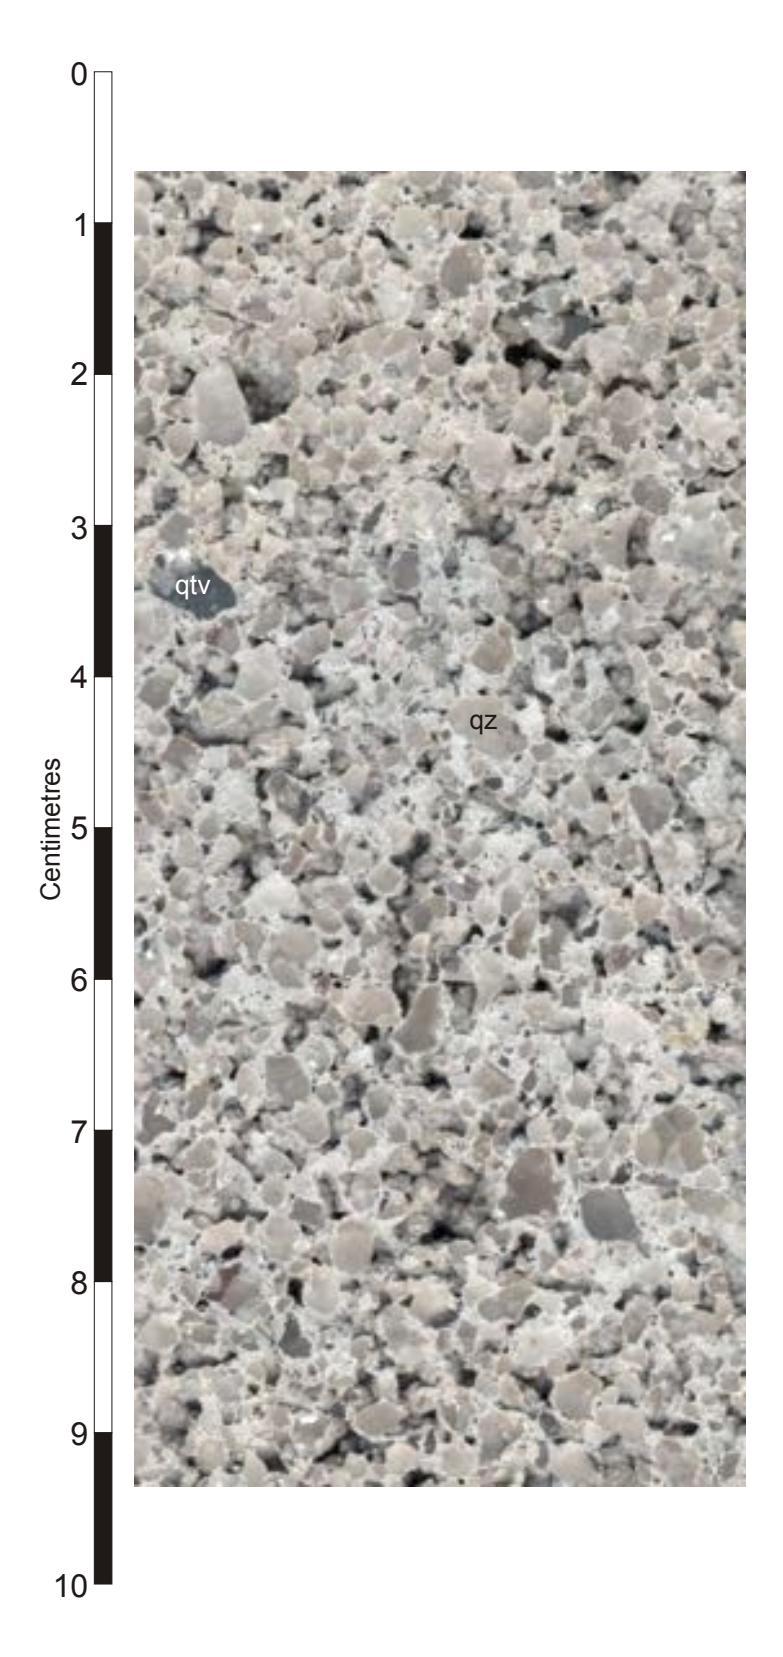
China Clay Waste

This fine china clay waste is commonly found in blockwork used for chimneys, internal walls, etc.

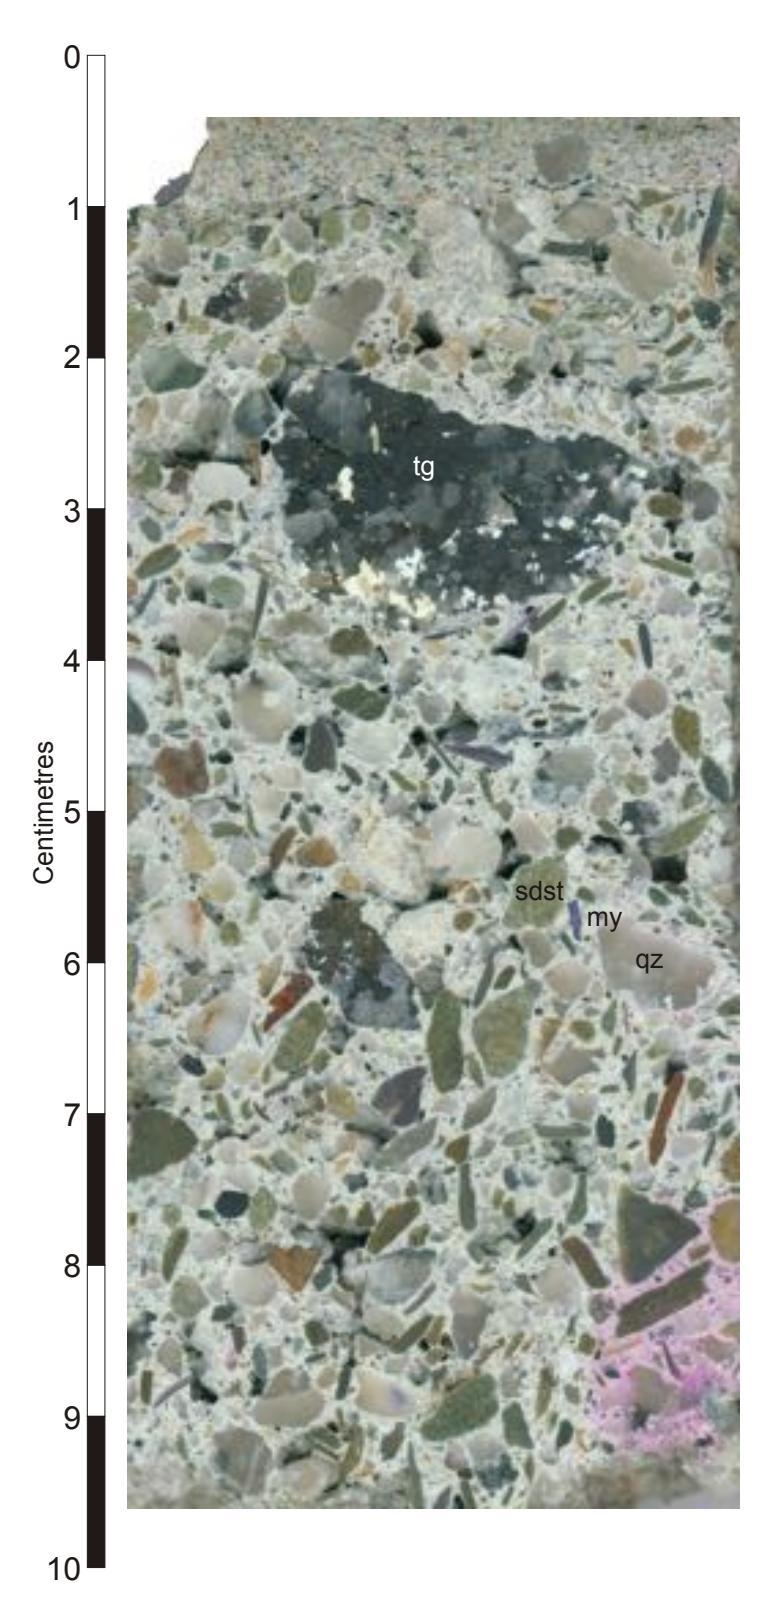
China Clay Waste, Beach Gravel Padstow

This combination of aggregates is found occasionally in north coast towns such as Newquay, Padstow and Wadebridge.

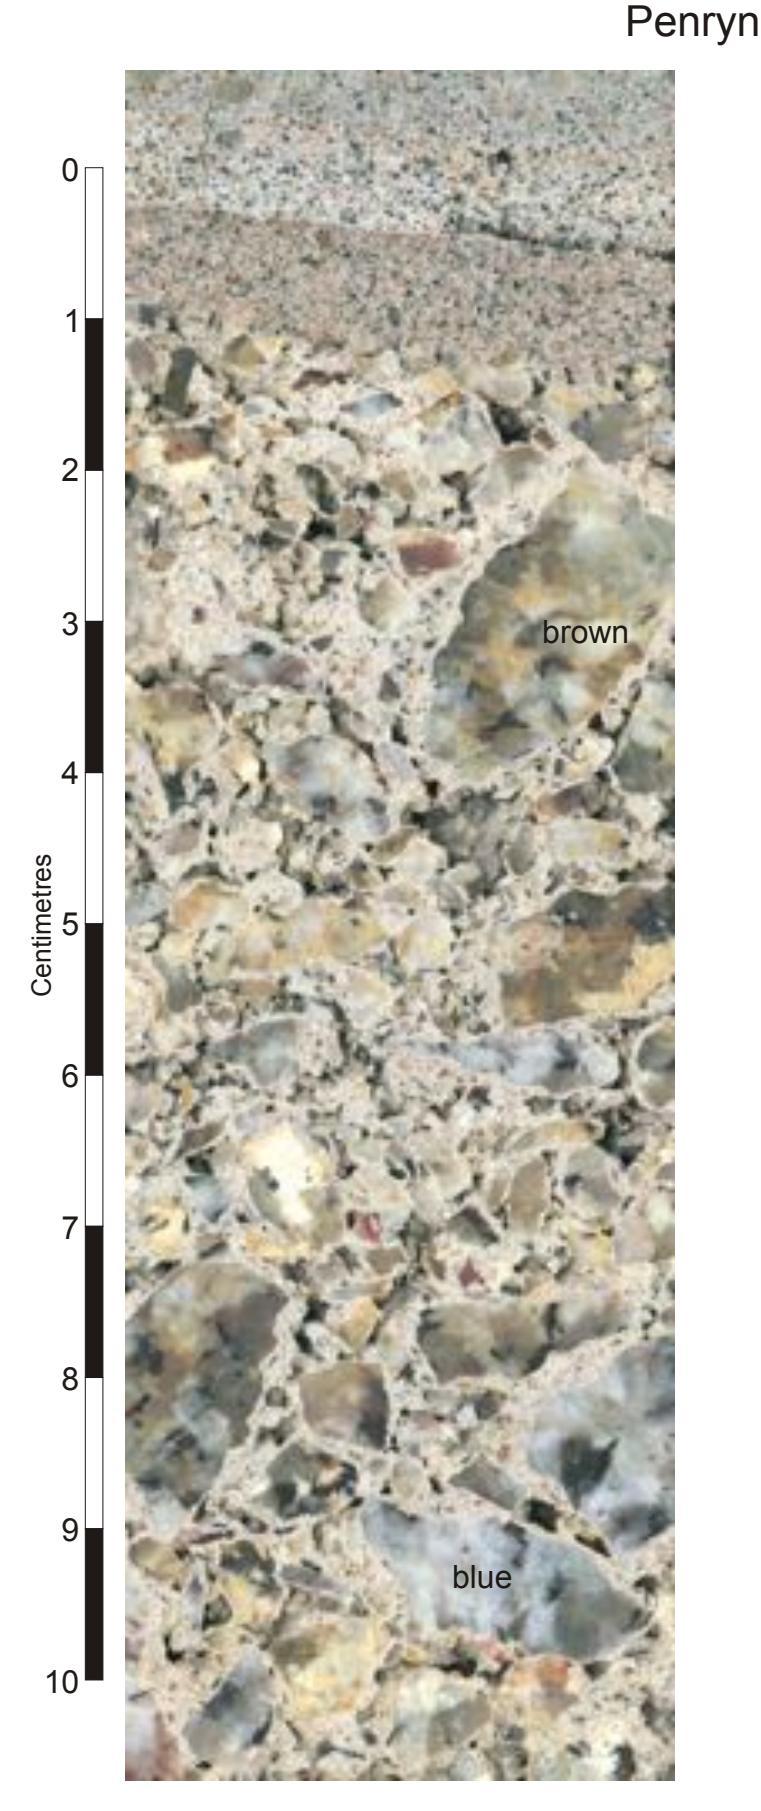
Coarse Grained Granite

Coarse-grained granite has been quarried from all of the major plutons in southwest England. It is widely used as aggregate in blockwork and in mass concrete.

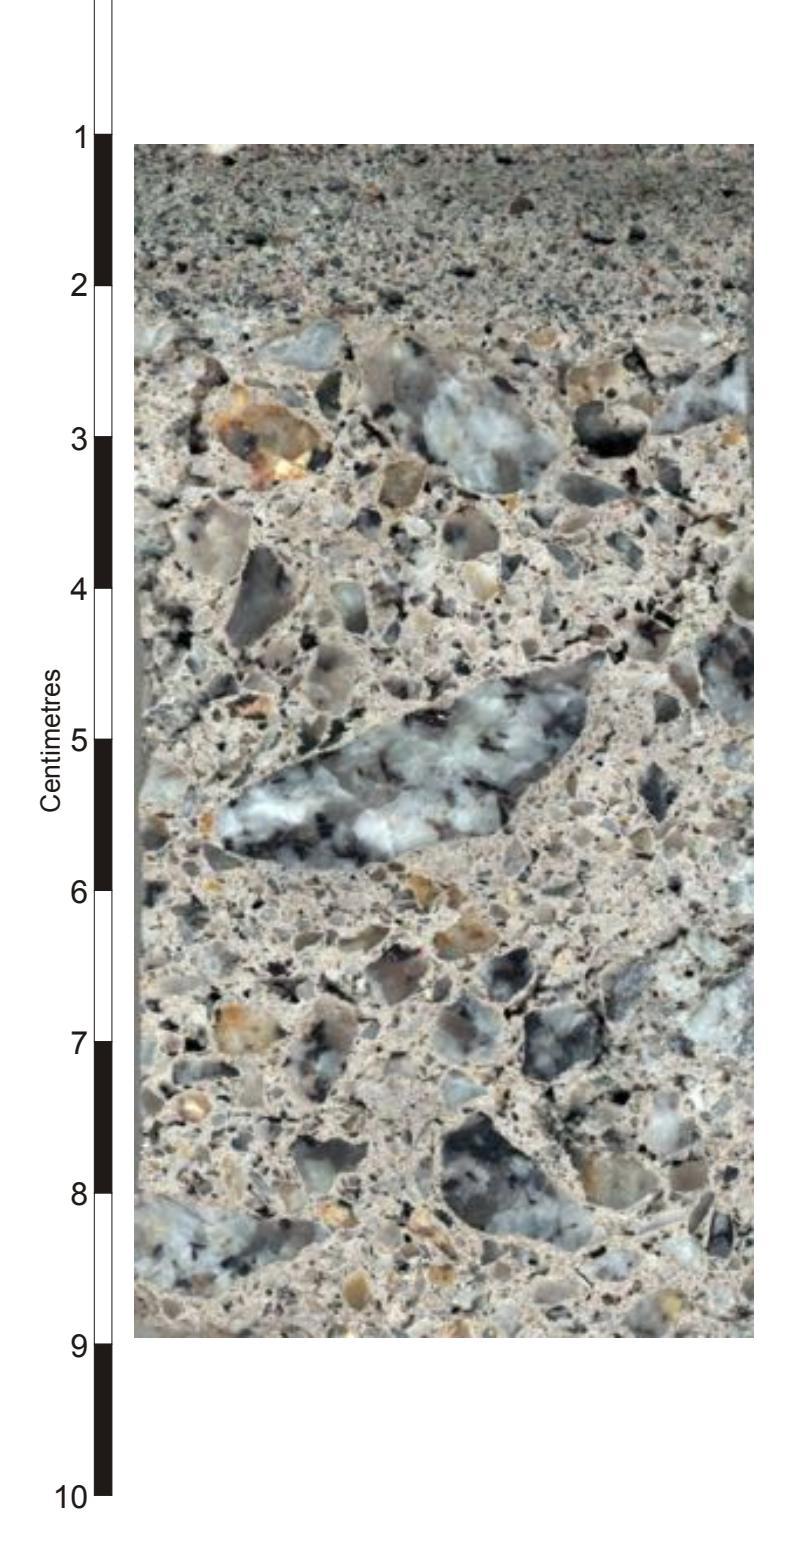
Mabe

This specimen if from blockwork. The material has high cement:aggregate ratio and is extremely hard. The all-in granite aggregate has larger maximum size than is normally found in concrete blocks.

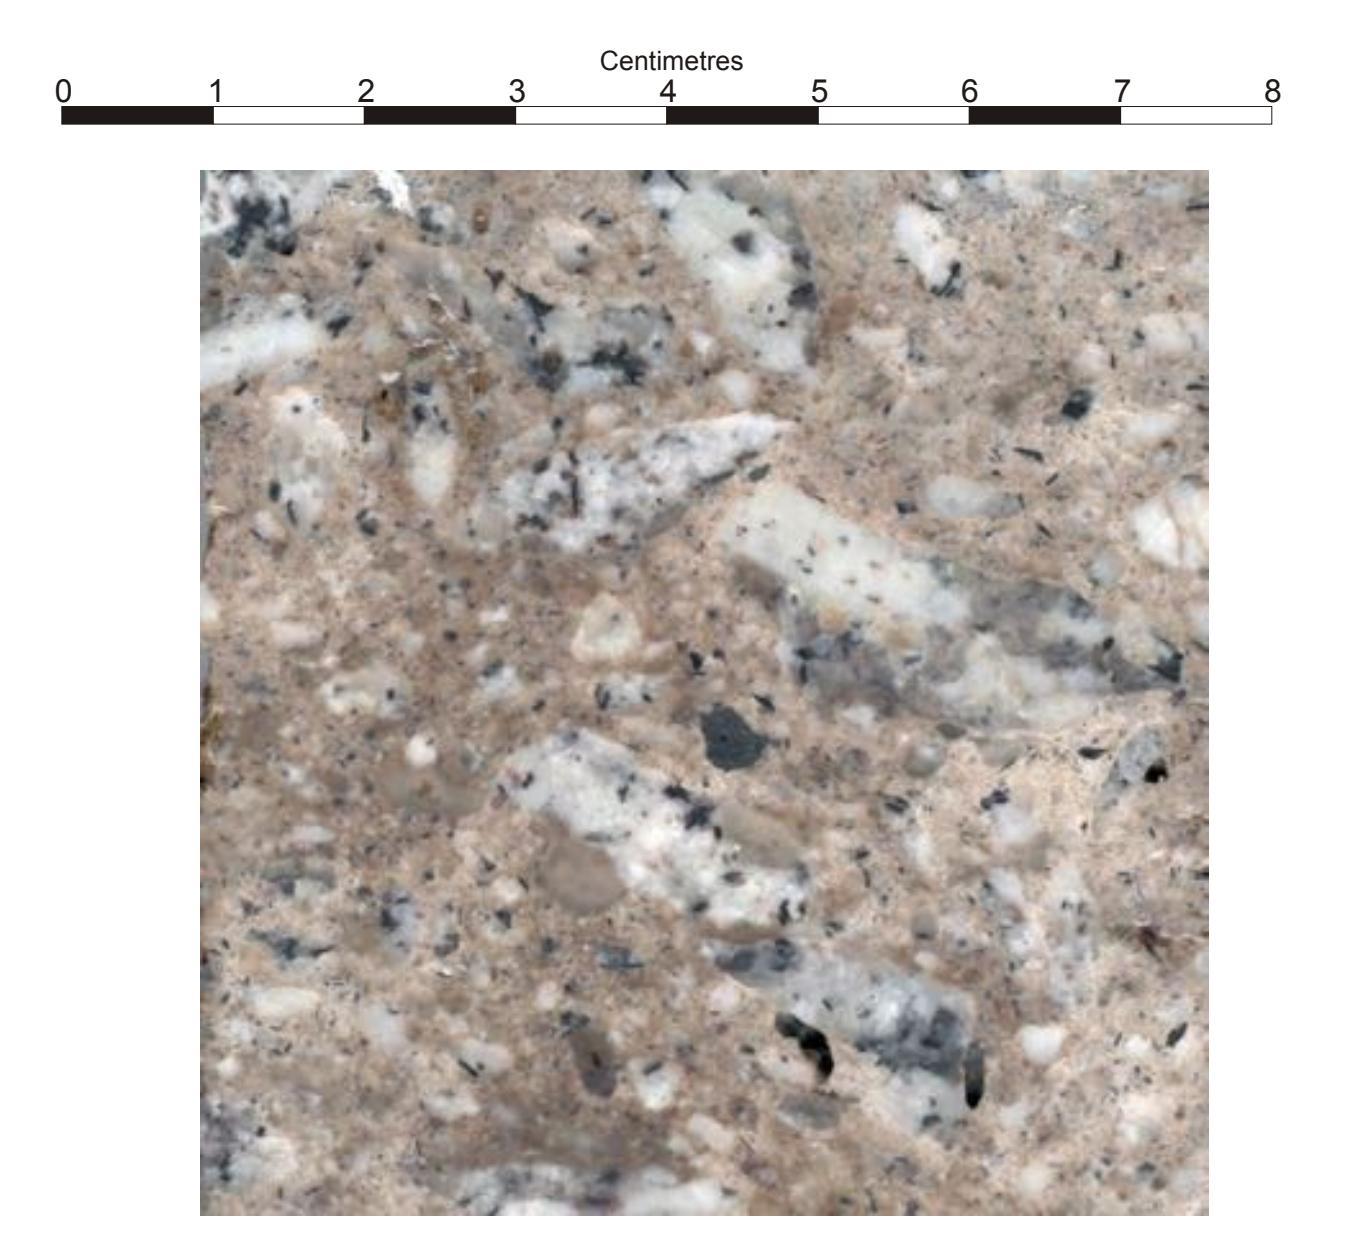
This specimen is from mass concrete foundations of a house in Devoran. The aggregate is a coarsegrained, two-mica granite quarried in the southern part of the Carnmenellis pluton. This material consists entirely of "blue" granite, quarried from below the zone of surface weathering. Note the characteristic porphyritic texture preserved in the large fragment near the middle of the plate. The main stage Carnmenellis granite consists of phenocrysts of alkali feldspar, up to 15 mm long, set in a matrix of orthoclase feldspar, plagioclase feldspar and quartz with subordinate muscovite, biotite, chlorite and tourmaline. The abundance of composite fragments, feldspar greatly in excess of quartz and biotite in excess of tourmaline, serve to differentiate quarried granite from china clay wastes.

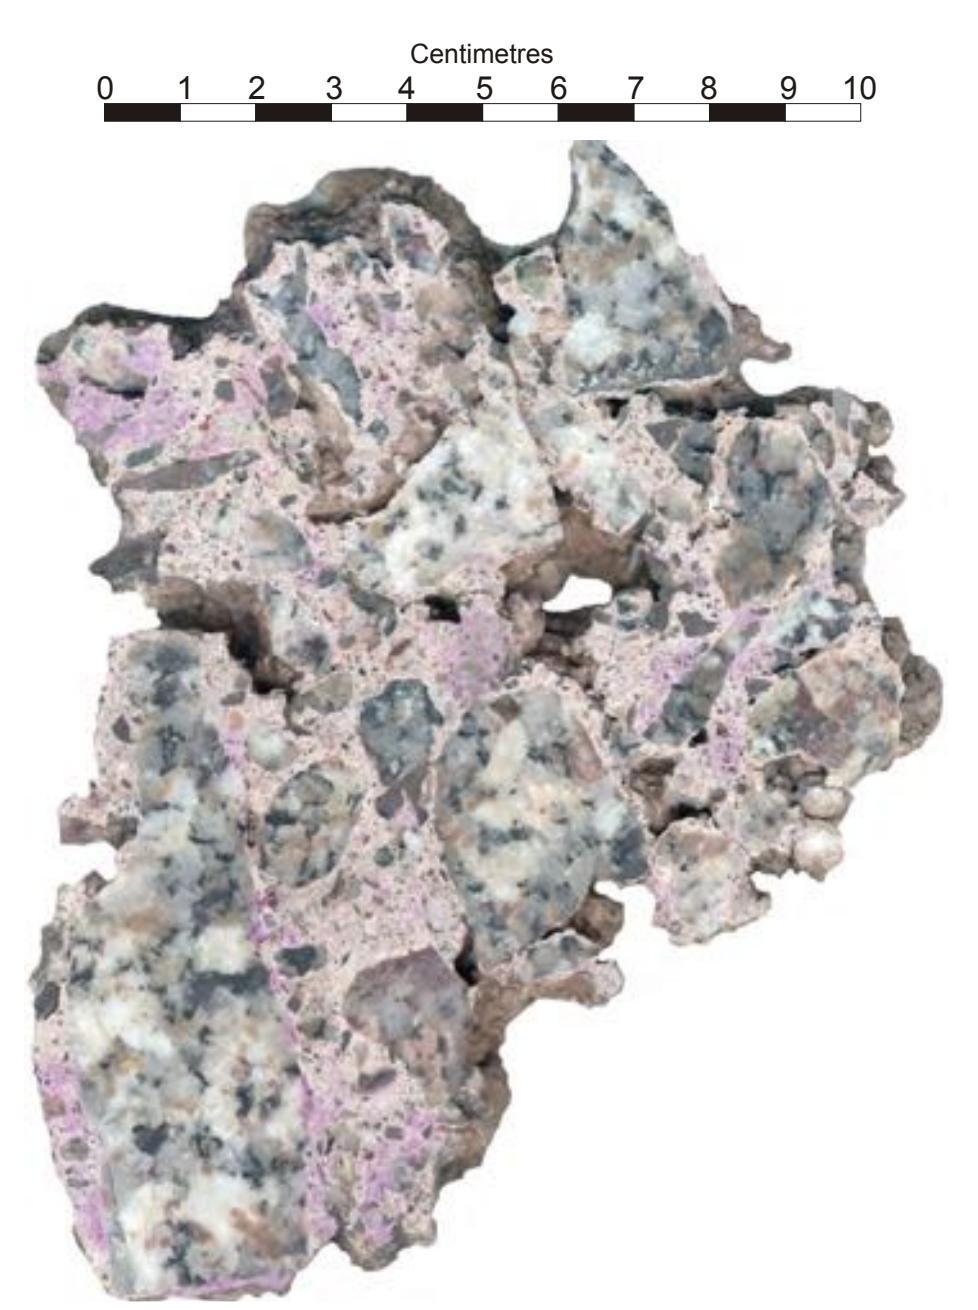
This specimen is from the mass concrete foundations of a house at Pool, between Camborne and Redruth. The aggregate is coarse-grained, two-mica granite, probably from Carn Brea or the Carnmenellis pluton. The concrete has low fines content and very high interconnected voidage.

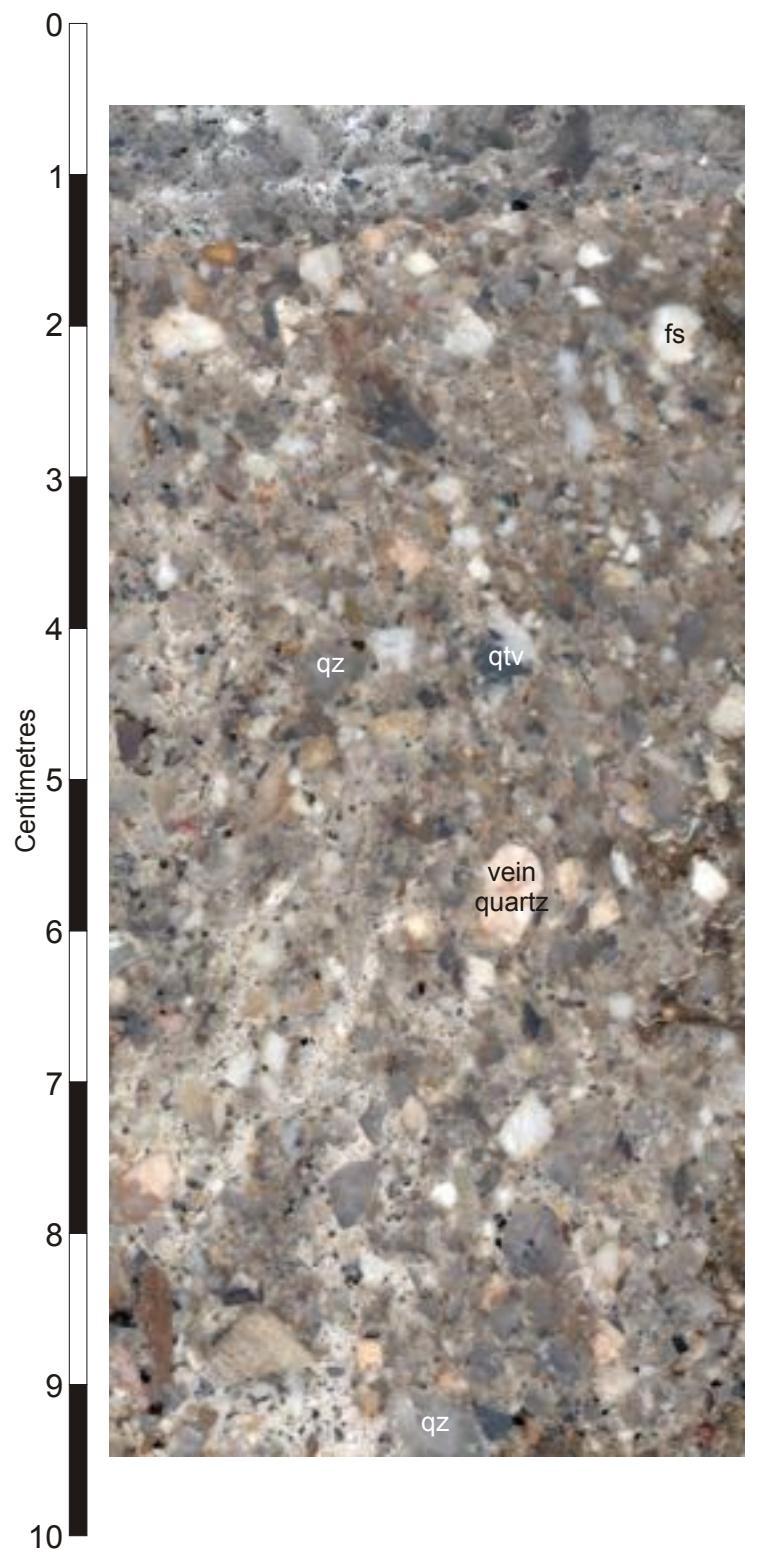
Concrete blockwork made with weathered coarse-grained granite aggregate is found occasionally in Bodmin and in scattered villages on and around Bodmin Moor. The source of the aggregate is not known but the lithology suggests a quarry or quarries in the coarse-grained Bodmin Moor granite.

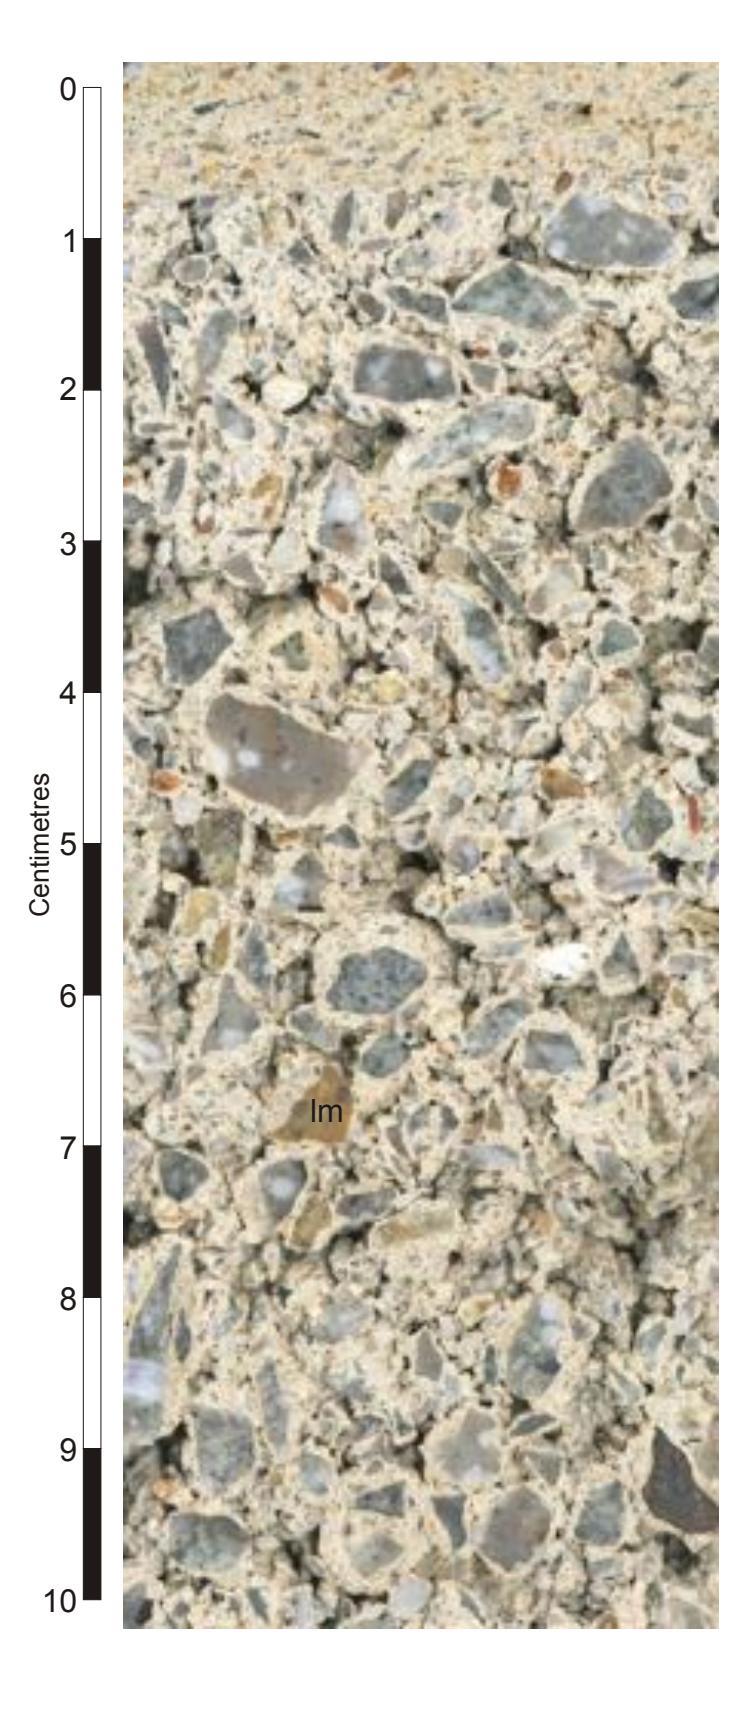
Fine-grained, two-mica granite, probably from the small Hingston Down granite mass between Callington and Gunnislake, was widely used as concrete aggregate in northeast Cornwall. It is often found in Bodmin, Liskeard, Callington, Saltash and surrounding villages.

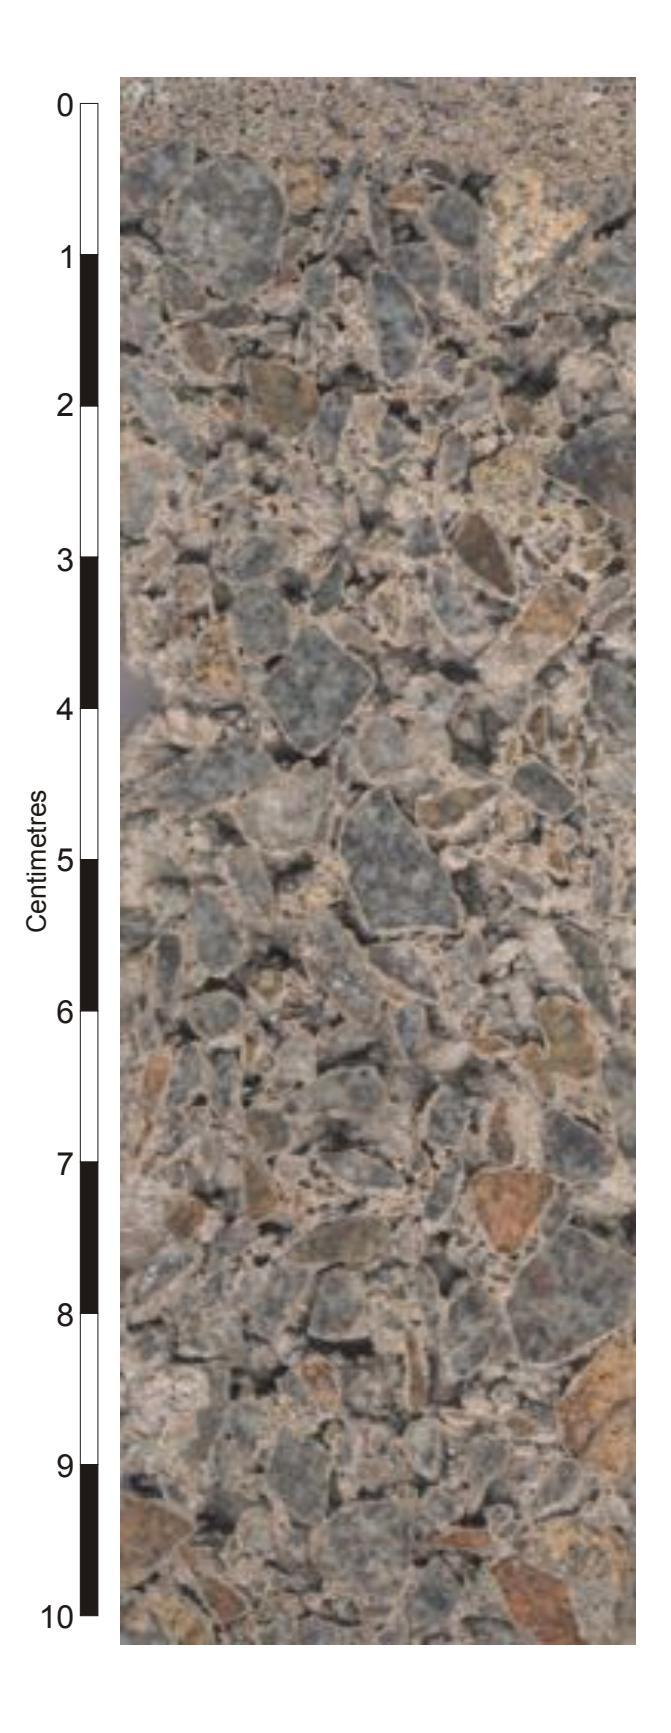
Fine-grained, two-mica granites were used extensively as concrete aggregates in East Cornwall. They came mainly from the Hingston Down granite stock, near Gunnislake, though it is possible that some aggregates were produced from finegrained granites in the Bodmin Moor pluton. The granite is made up from feldspars and quartz with subordinate biotite, muscovite, chlorite and tourmaline. Some granite from the Hingston Down stock carries sulphide minerals, though usually in very low concentrations.

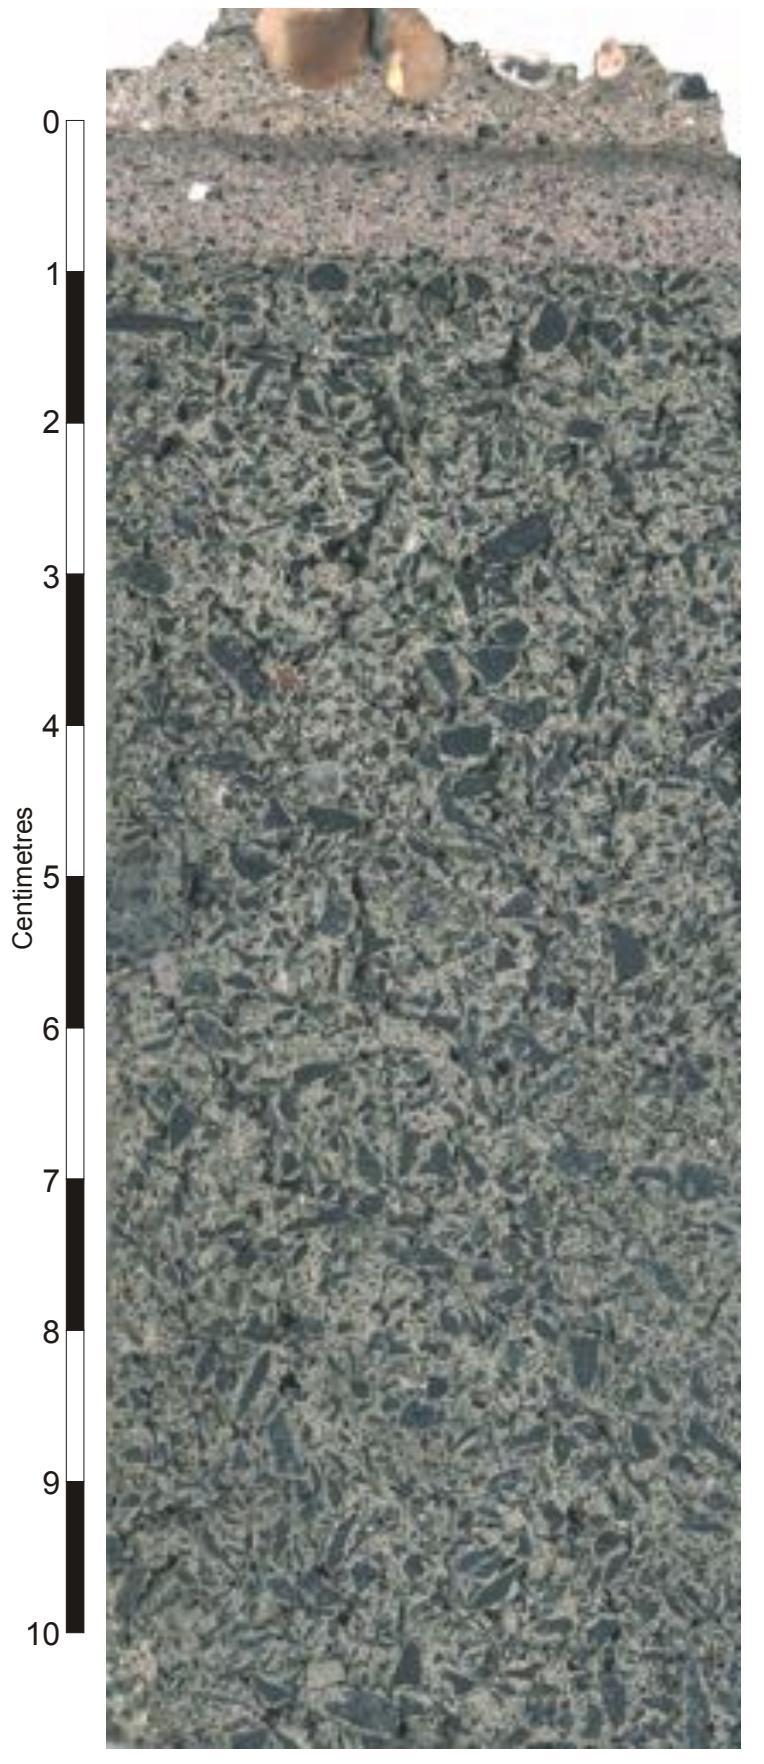
This aggregate is from the Crousa Downs tectonic unit of the Lizard ophiolite complex. The main source was probably the former West of England quarry at Porthoustock. The quarry is developed in the root zone of the sheeted dyke complex and the product includes gabbros and various fine to mediumgrained dolerite dyke rocks. White plagiogranite, amphibolite, granulite and mafic mylonite from high strain zones occur in minor amounts.

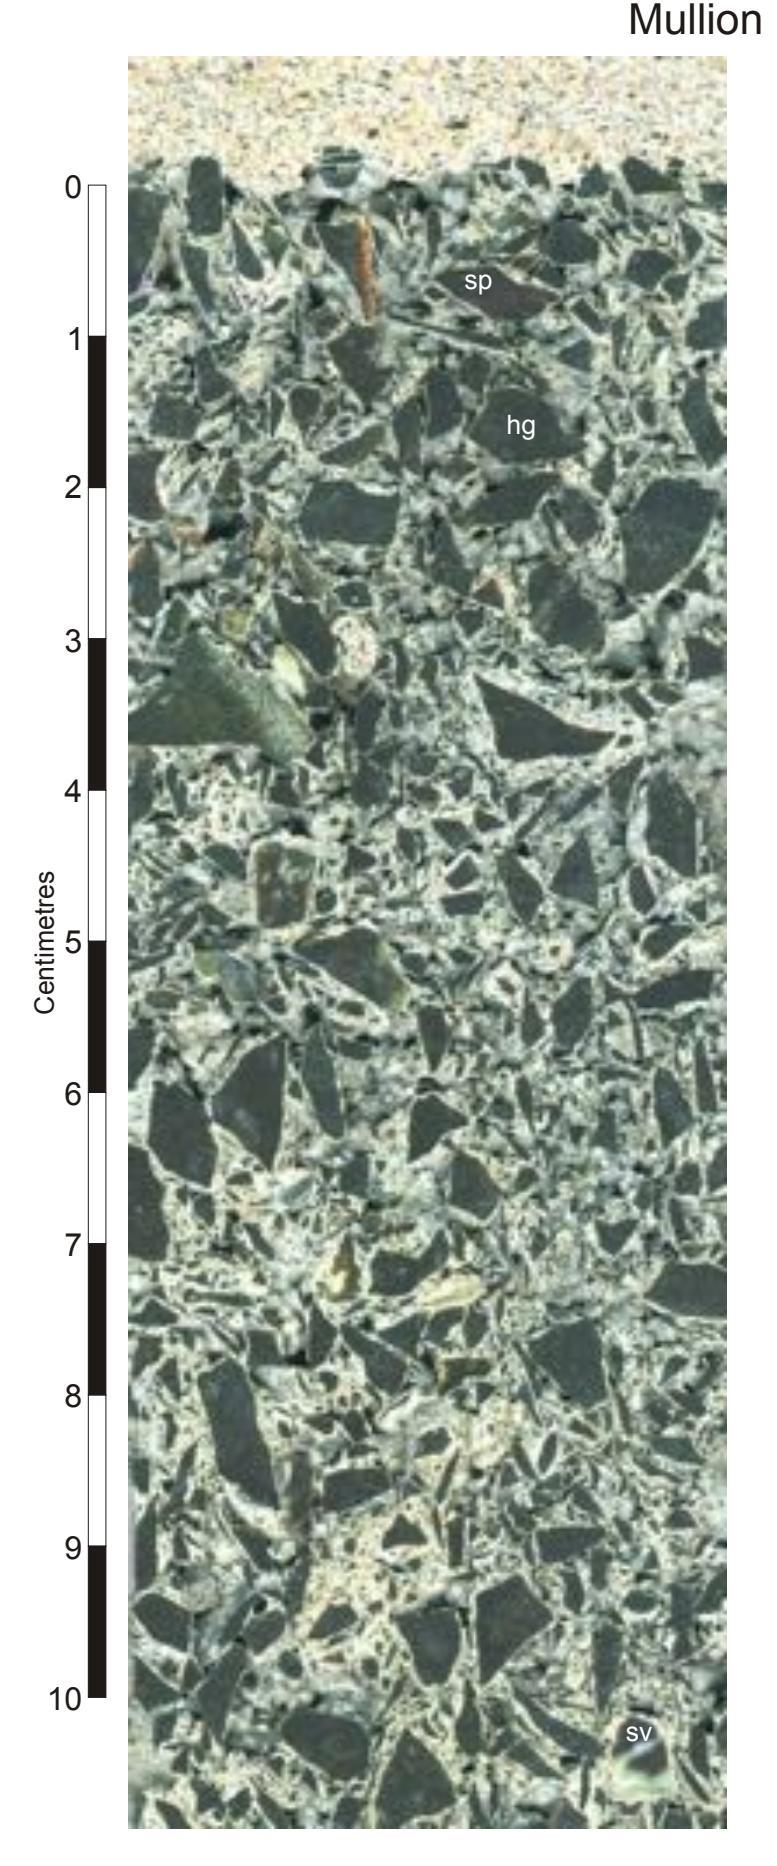
This Lizard aggregate is from a house in Mullion on the northwest coast of the peninsula. It is probably of local origin, won from one of the small former quarries in hornblende granulite between Mullion and Mullion Cove.

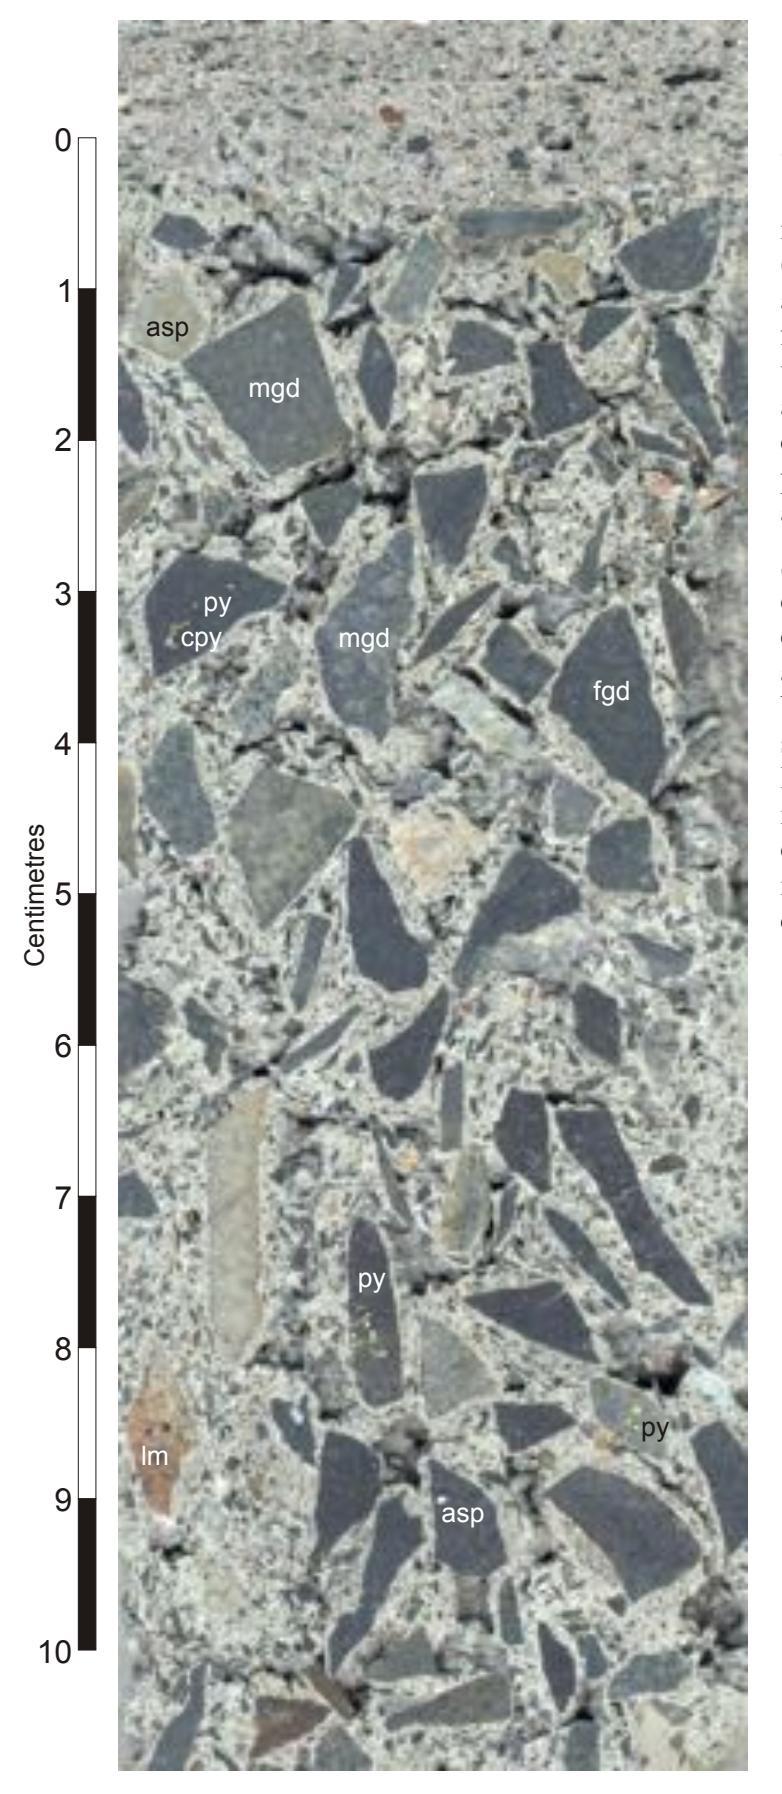
The aggregate in this blockwork from a house in Penzance is the well-known metamorphosed dolerite from Penlee (Gwavas) Quarry at Newlyn. Fine-grained and medium-grained metadolerite fragments (fgd, mgd) predominate. Various veinstones and vein quartz occur in minor amounts. Several veinstone fragments carry disseminated sulphide minerals, including pyrite (py), chalcopyrite (cpy) and arsenopyrite (asp).

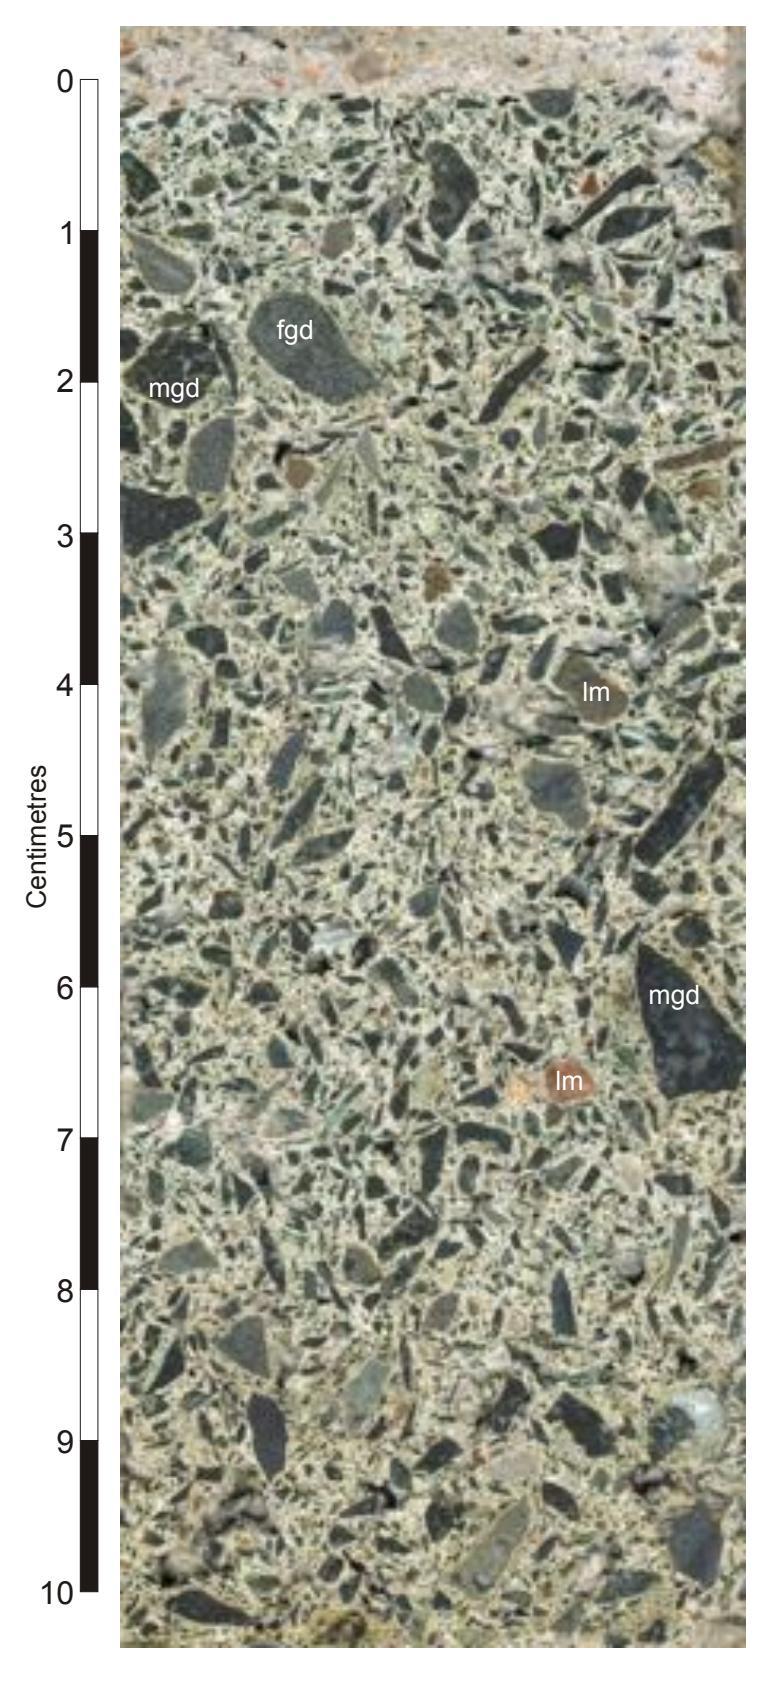
The specimen is from blockwork in Gunnislake though the aggregate is probably from South Devon. It is quarried dolerite. As usual, the primary assemblage of clinopyroxene + plagioclase feldspar ` olivine is partly replaced by saussuritised plagioclase + green hornblende + chlorite + leucoxene.
