Petroab Ltd, C Edwards Offices, Gweal Pawl, Redruth, Cornwall TR15 3AE, United Kingdom

A compendium of concrete aggregates used in Southwest England

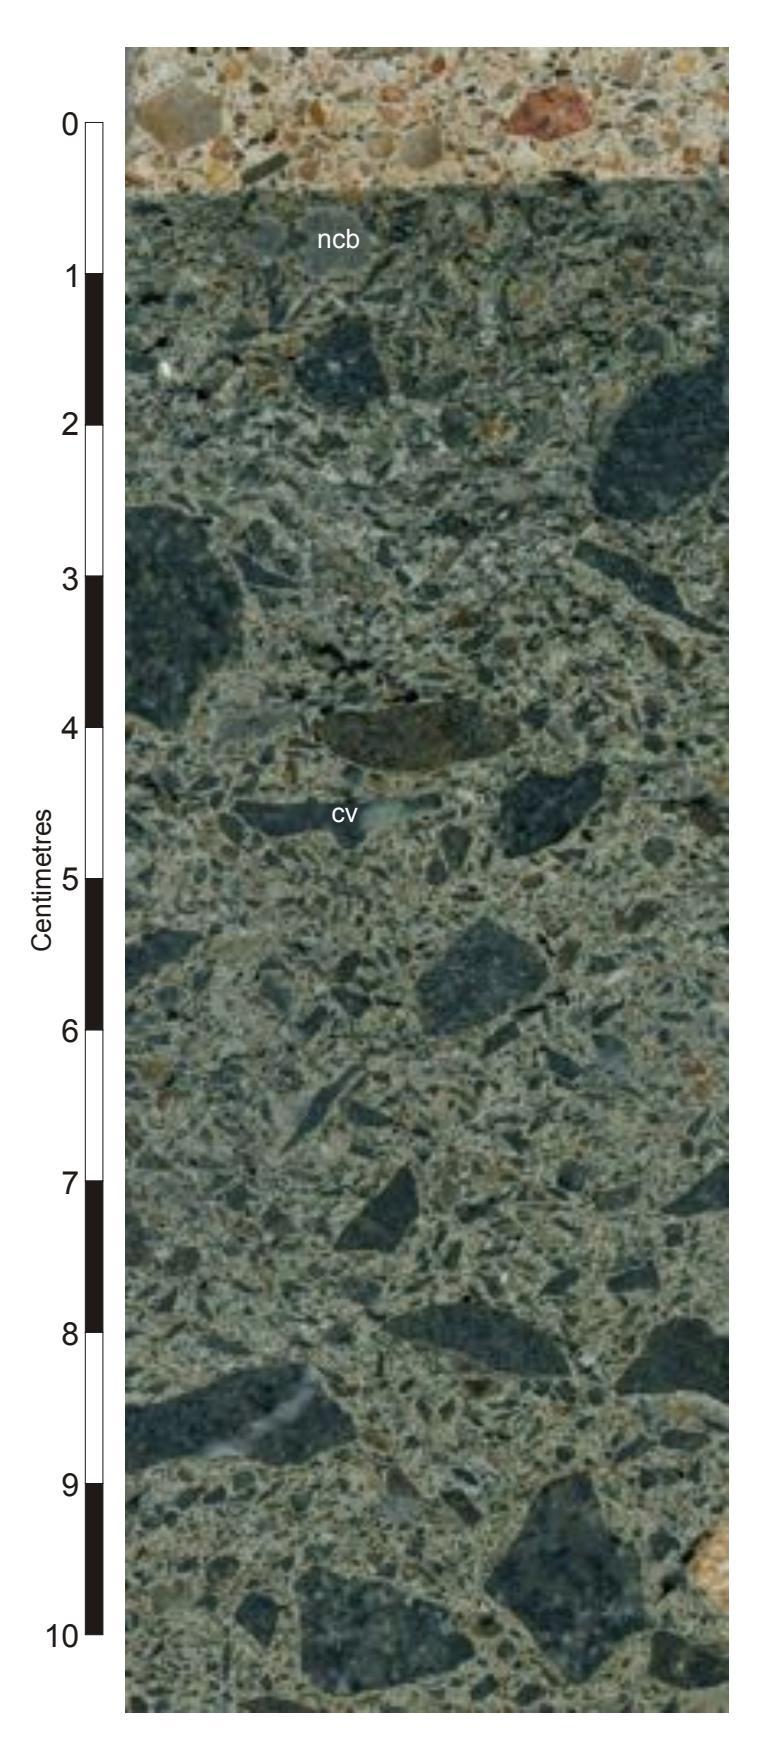
This is mass concrete from the foundations of a house in Saltash. It is a quarried dolerite from East Cornwall. The aggregate is probably an all-in material though it is less well-graded than that normally used in blockwork and has a larger maximum size.

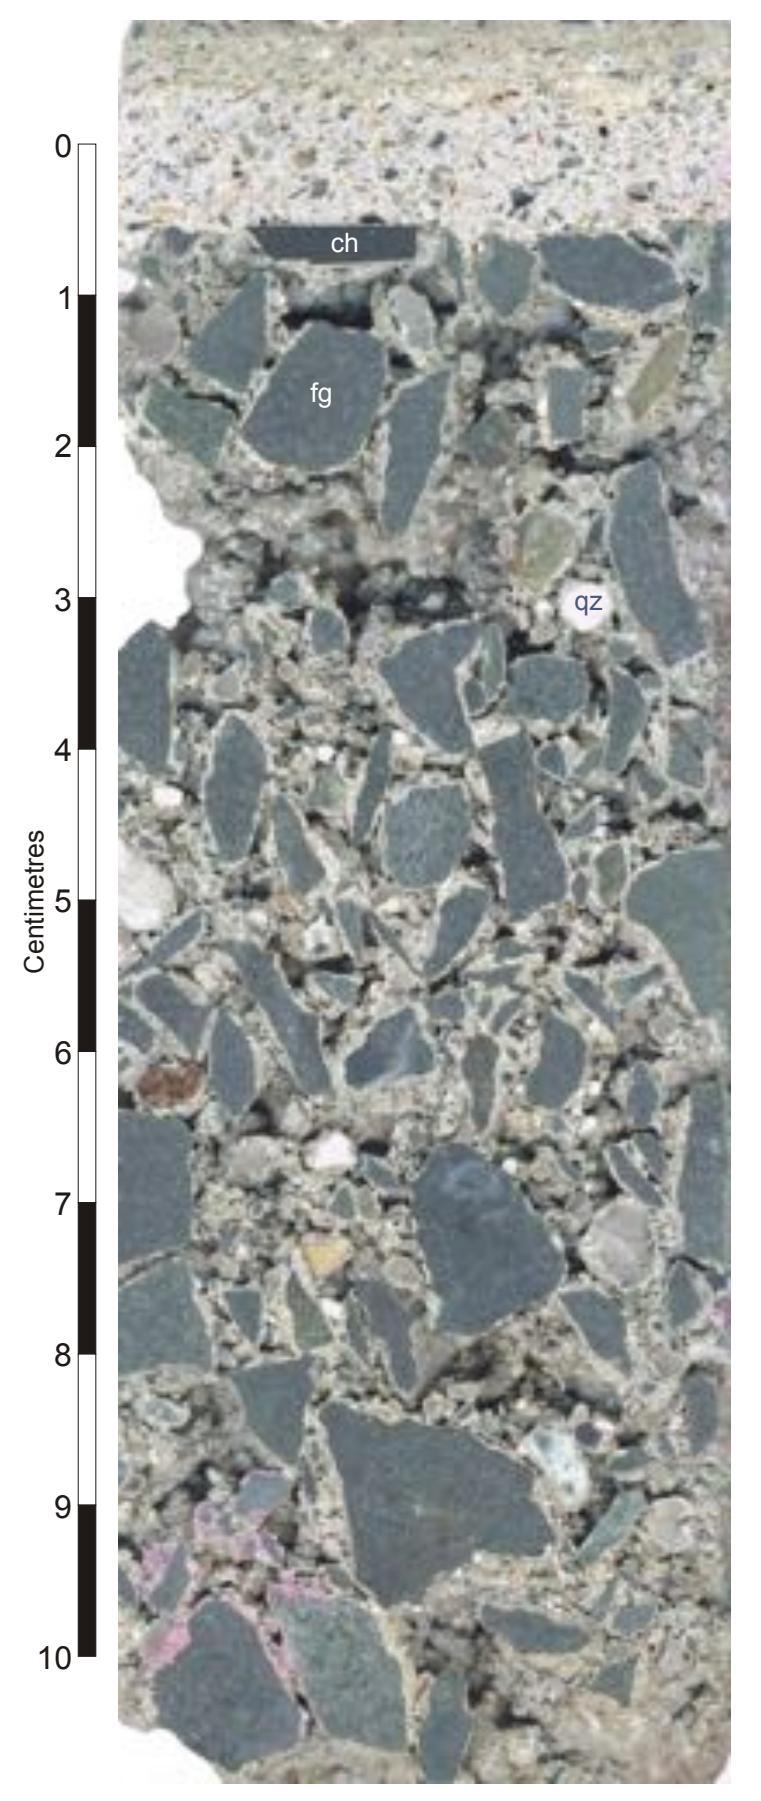
This aggregate is a single quarried product. It consists of a mixture of fine-grained, altered dolerite (fg), probably from a small, high level intrusion and black, often pyritic chert (ch). The chert comes from wall rocks adjacent to the dolerite intrusion. Other minor components include vein quartz (qz) and chloritic veinstones.

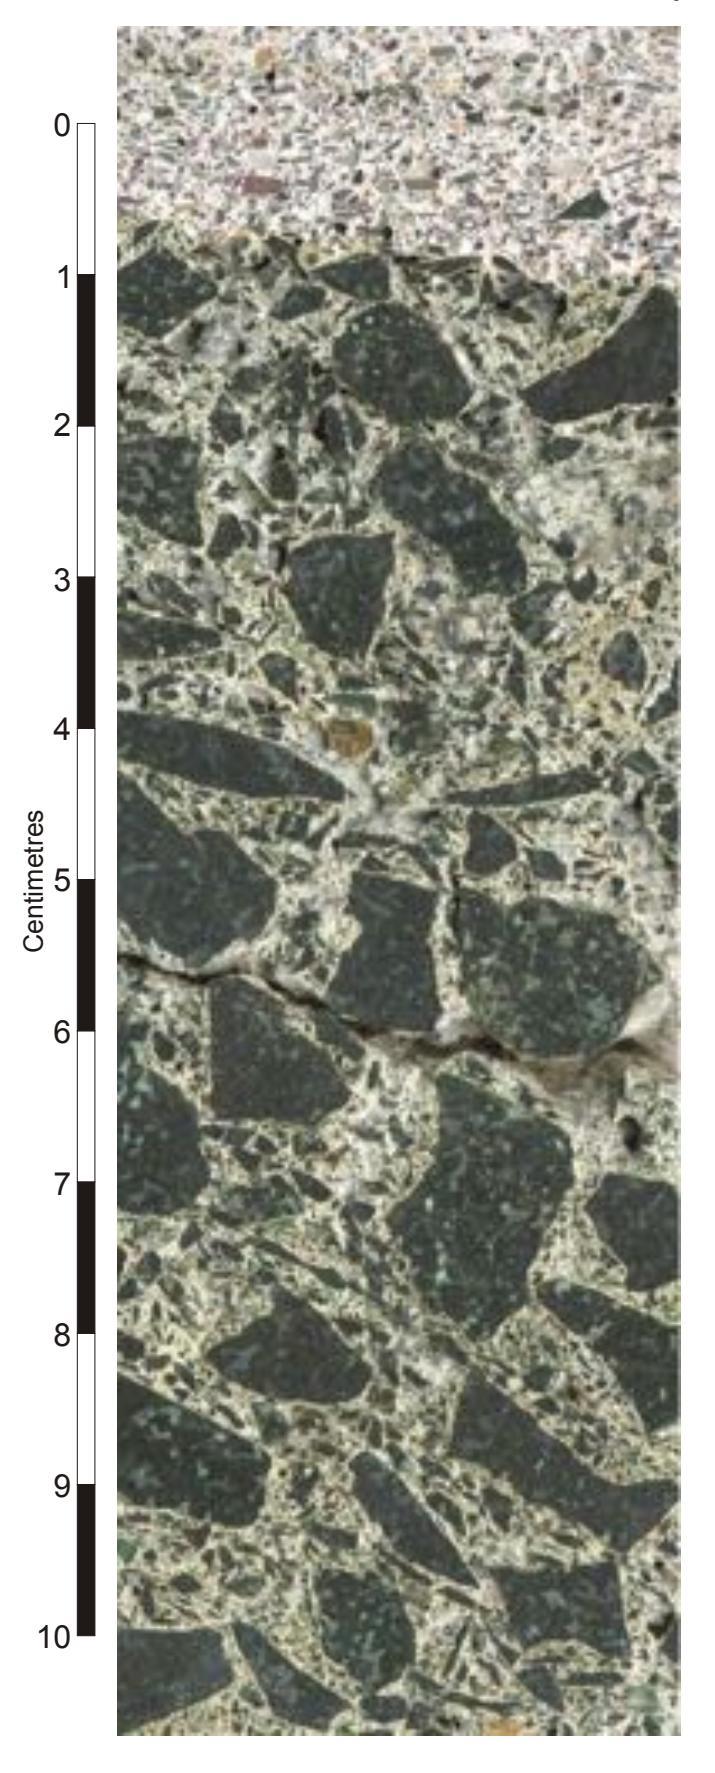
The former Clicker Tor Quarry, Liskeard was developed in a serpentinised cumulate picrite. The primary assemblage is cumulus olivine + intercumulus clinopyroxene + abundant granular magnetite. It is moderately to completely altered with the primary minerals replaced by serpentine + tremolite + stilpnomelane. There are also occasional fragments of serpentine + carbonate veinstones. The aggregate is easily recognised by its dark green colour and the distinctive mottled texture of large composite fragments. The aggregate was used extensively in the Liskeard - Looe area of East Cornwall.

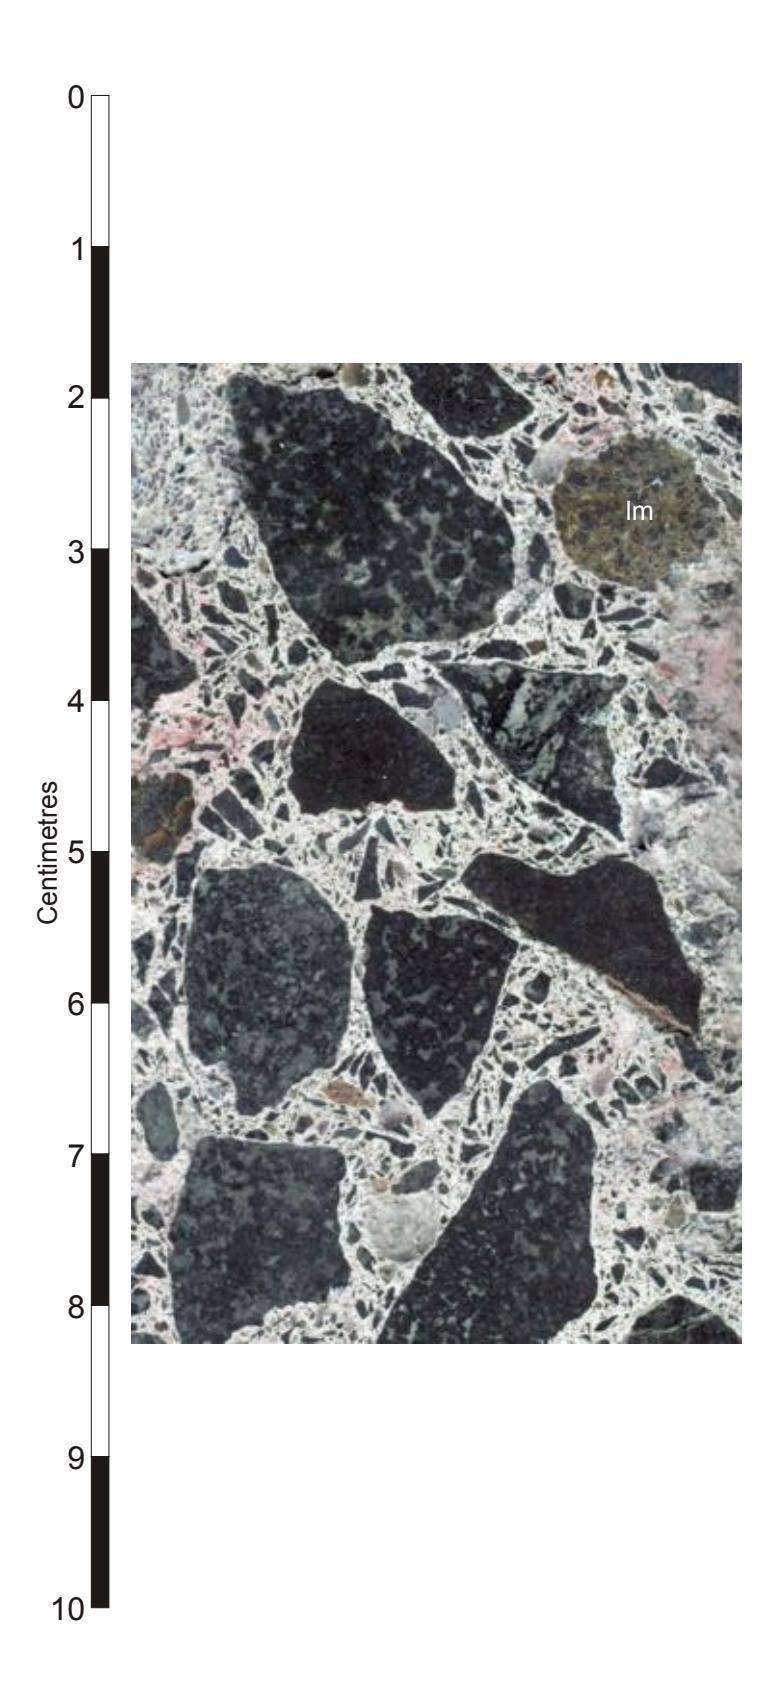
These gap-graded aggregates in foundation concrete from a house in West Looe, are both from the former Clicker Tor Quarry, near Menheniot.

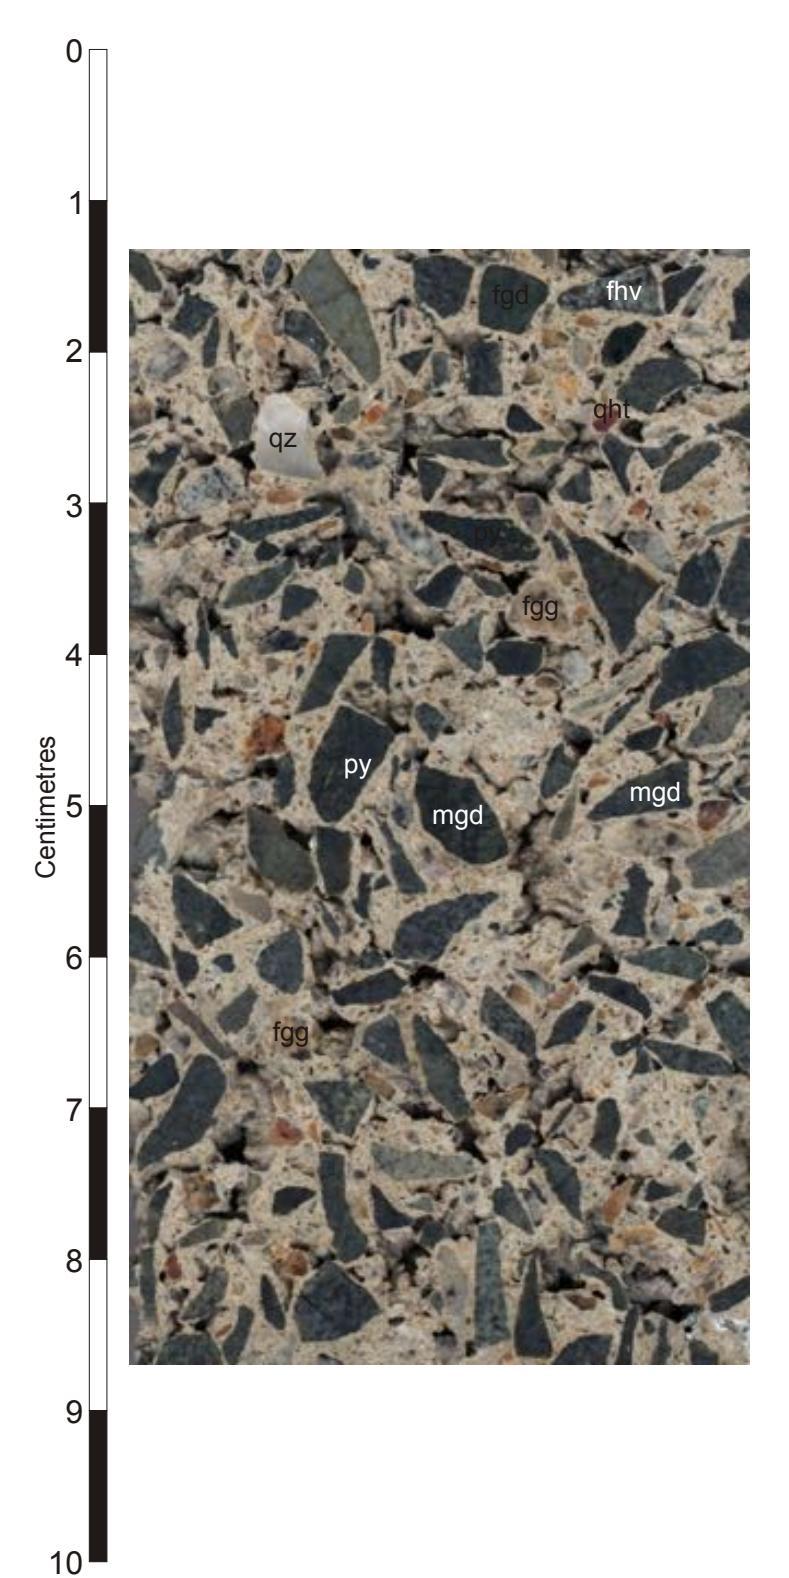
The sulphide-mineralised metamorphosed dolerite from Penlee Quarry, near Newlyn, is normally stable, even though it may contain more than 1% equivalent pyrite. The potential effects of *in situ* sulphide oxidation are reduced when the metadolerite is blended with other stable aggregates.

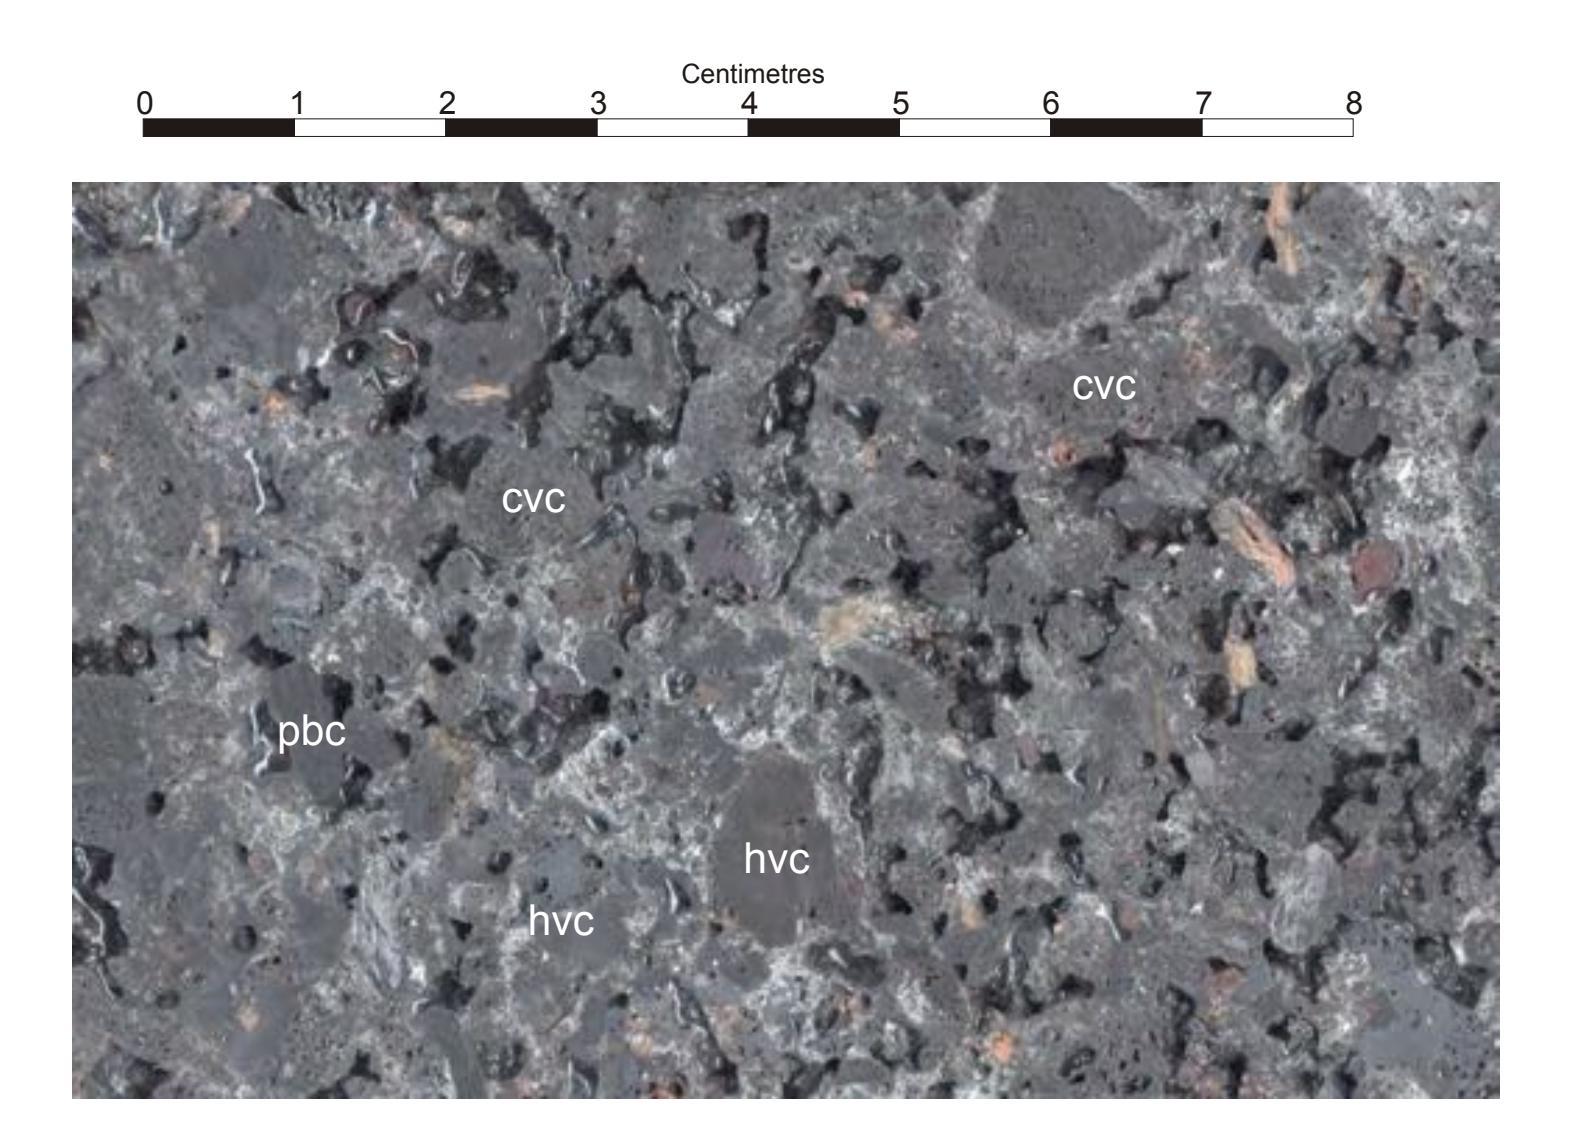
This well-made concrete is from the foundations of a house in Hayle. The aggregate is furnace clinker, probably from the former coal-fired power station at Hayle.

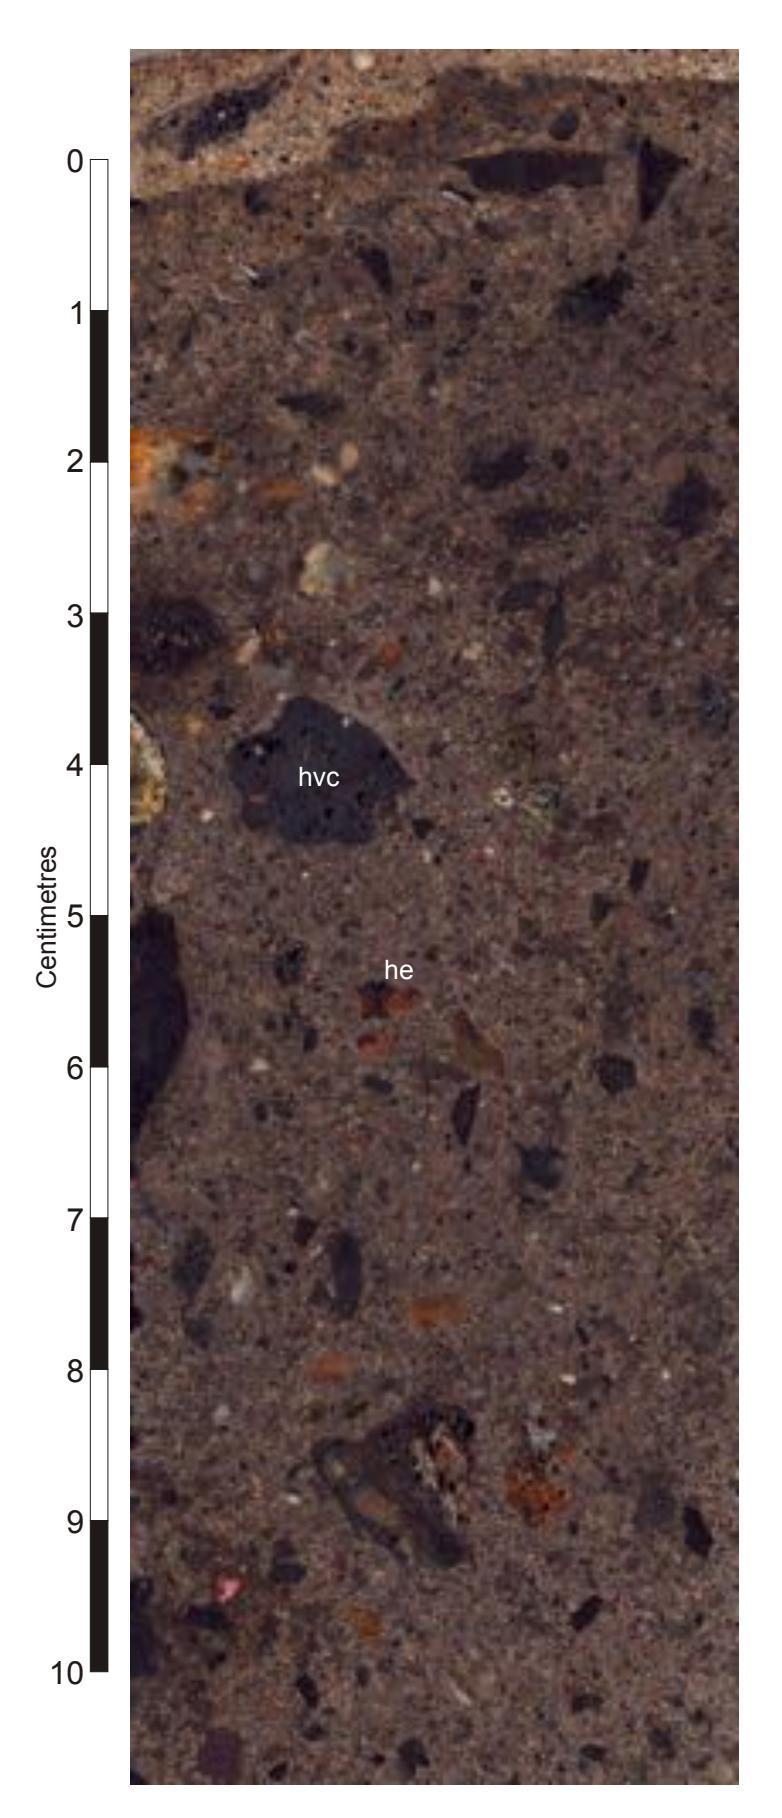
Furnace clinker aggregates are common throughout the region. This example is from St Just in Penwith. It is very likely that the clinker is from a steam-raising furnace associated with the mining industry. Strongly oxidised clinkers appear to be characterictic of mine furnaces and are found in most of the former mining areas of Cornwall.

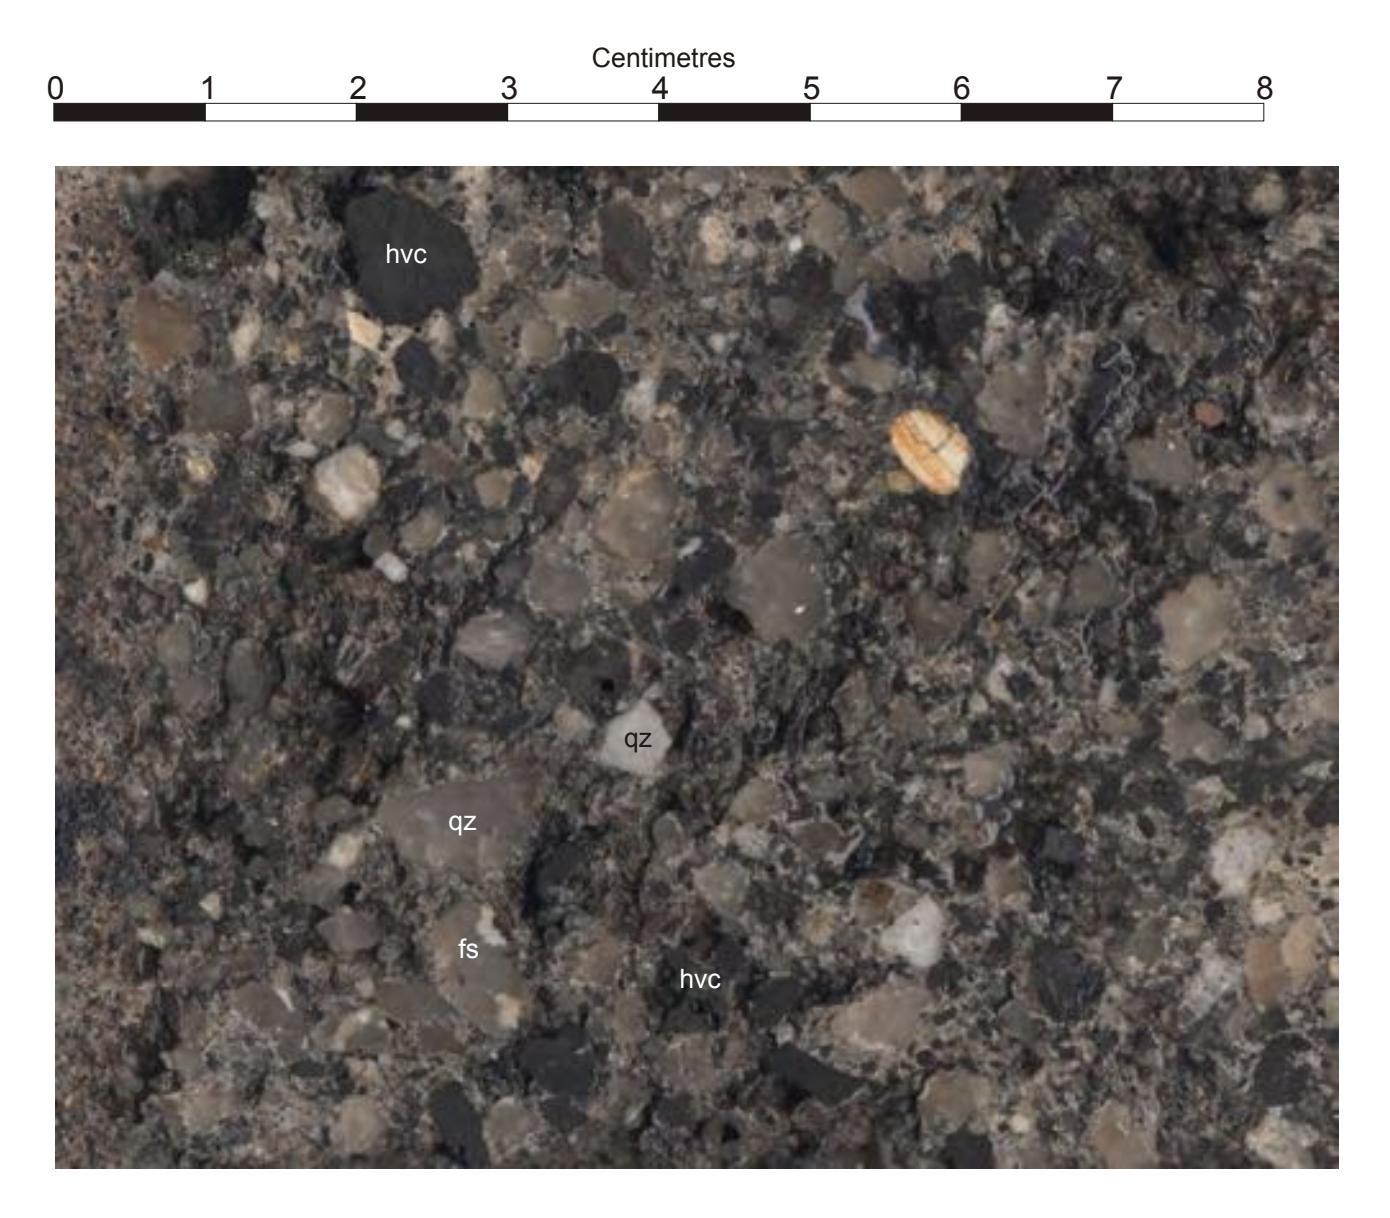
Furnace clinker and copper smelter slag are common aggregates in the Hayle area. The sources are a former coal-fired power station and important copper smelting works that operated during the eighteenth and nineteenth centuries. This specimen is from mass concrete foundations. The aggregates are furnace clinker and china clay waste in approximately equal proportions.

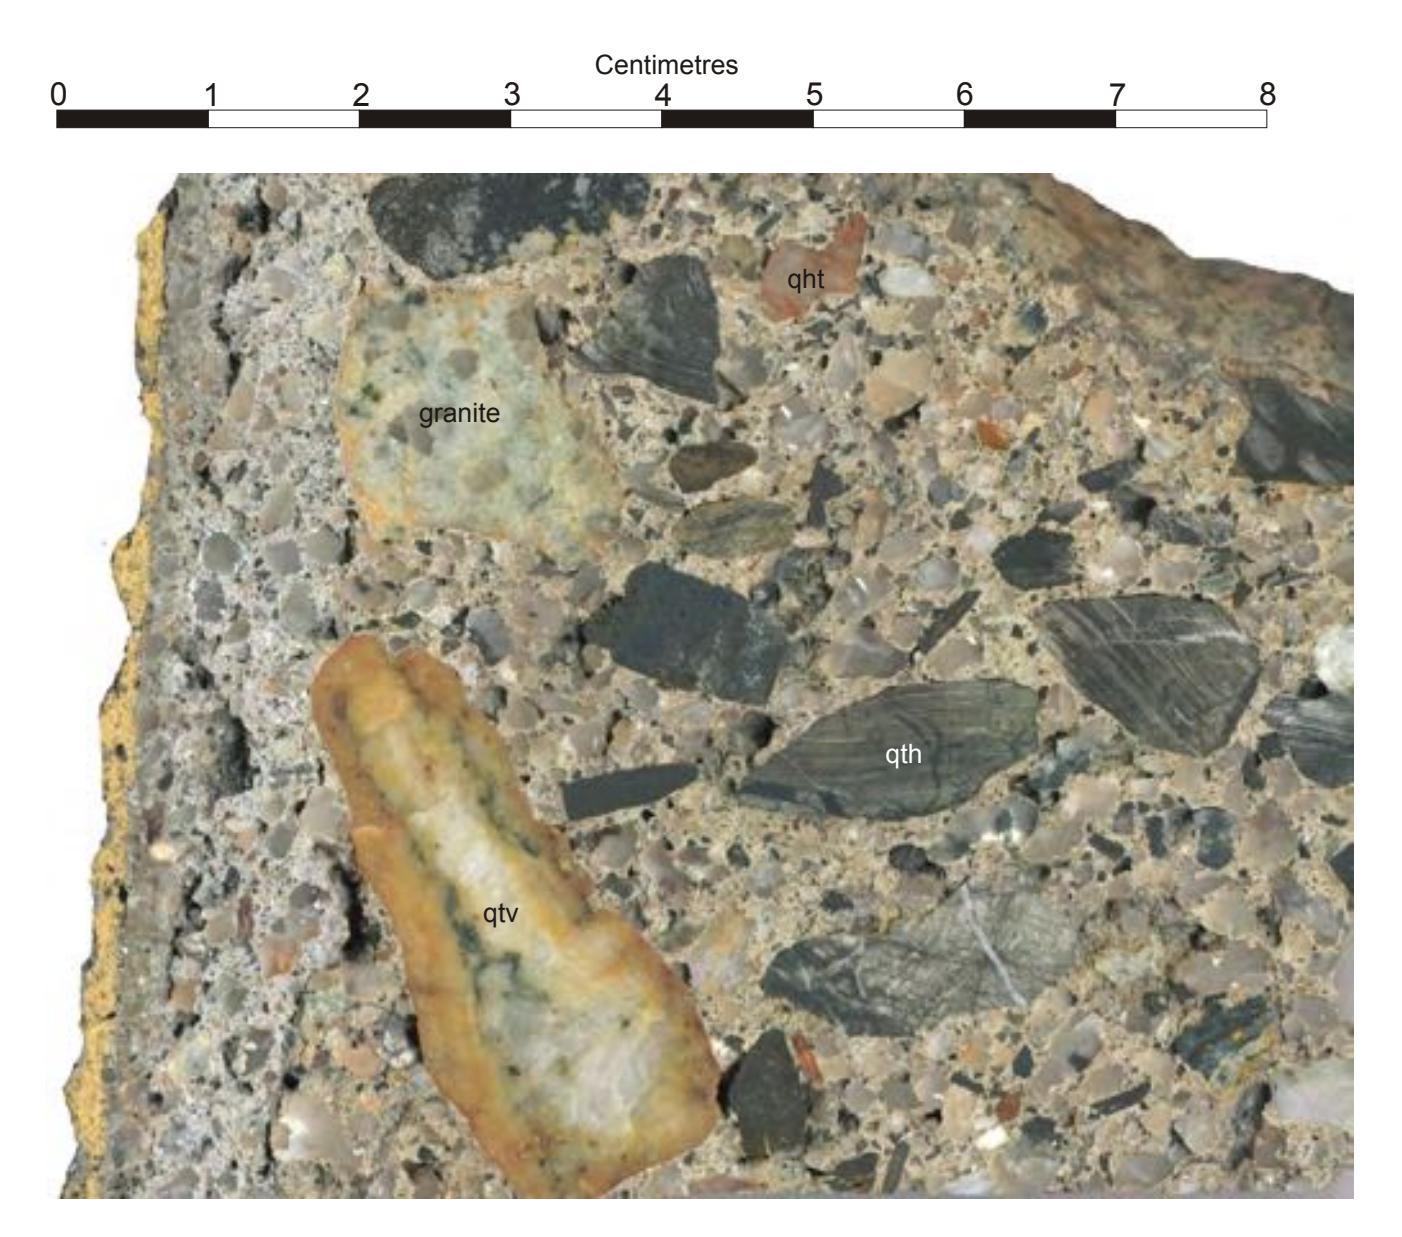
This concrete is made with tin mining waste from the metamorphic aureole overlying the western flank of the St Austell granite. The host rocks include finely banded quartz - tourmaline hornfels (qth), quartz - tourmaline veinstones (qtv) and vein quartz. Granite and quartz - haematite veinstones (qtt) occur in minor amounts. The mineralisation is characterised by extremely low sulphide mineral concentrations. Sulphides are very rarely found in the aggregate. Because the principal components are made from resistant tourmaline and quartz the aggregate is very stable. There are no recorded instances of aggregate-related degradation and for this reason it is classified as a group 1-6 material. Pervasive limonitisation of some veinstone fragments is the result of low temperature hydrothermal alteration or weathering before the concrete was made (note the absence of an iron oxide impregnation halo round the large limonitised quartz - tourmaline veinstone fragment).

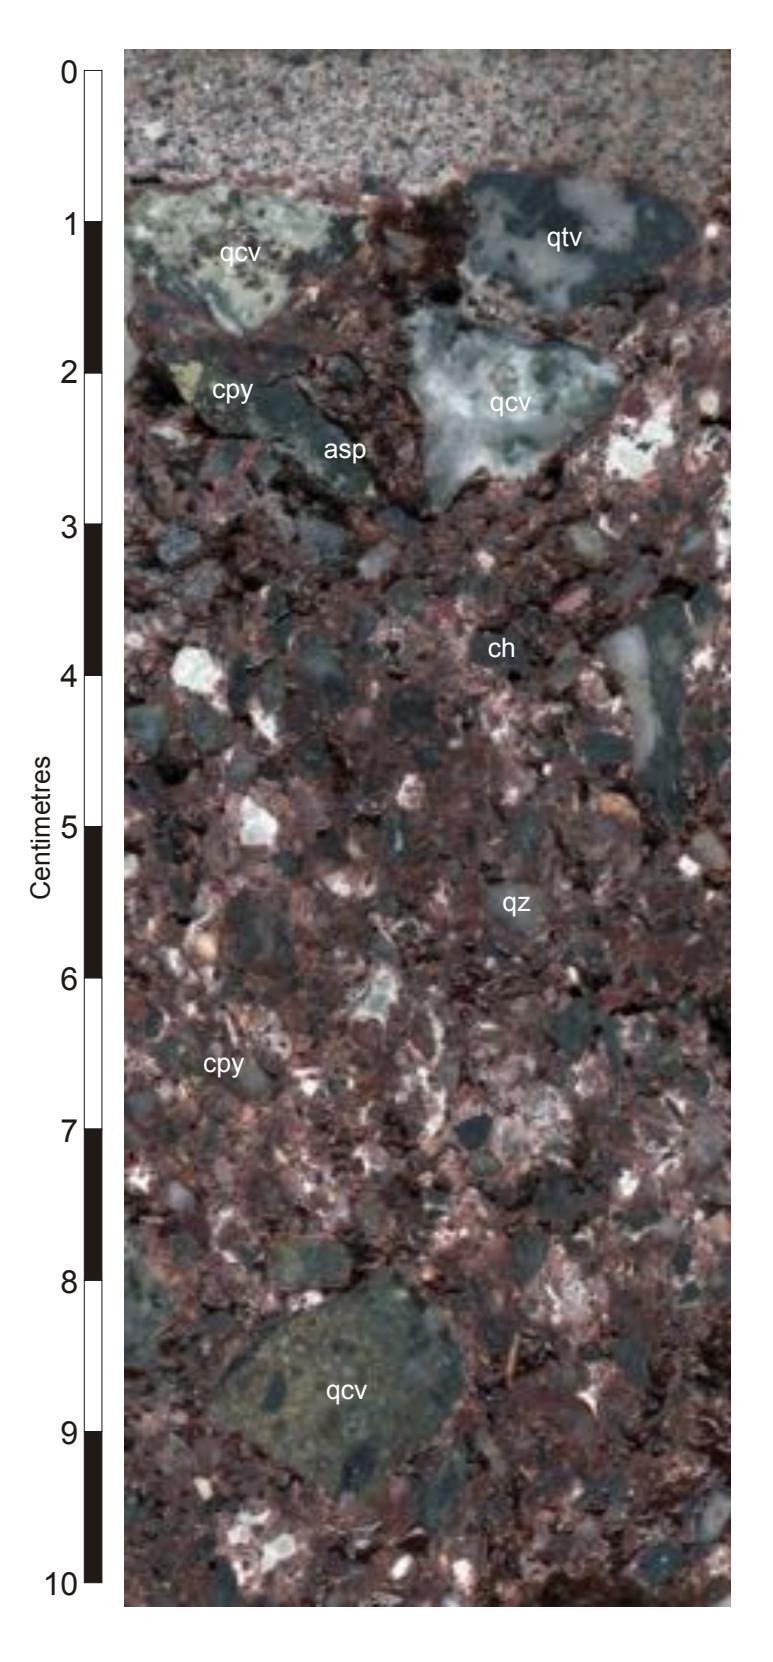
This aggregate is typical of a range of high sulphide mine wastes that are responsible for most serious concrete degradation in the Camborne - Redruth area. It is a by-product of the hypothermal, exogranitic tin - copper - arsenic mineralisation in the area overlying the Carn Brea granite ridge. Similar materials were used as concrete aggregates in the St Day mineralised district.

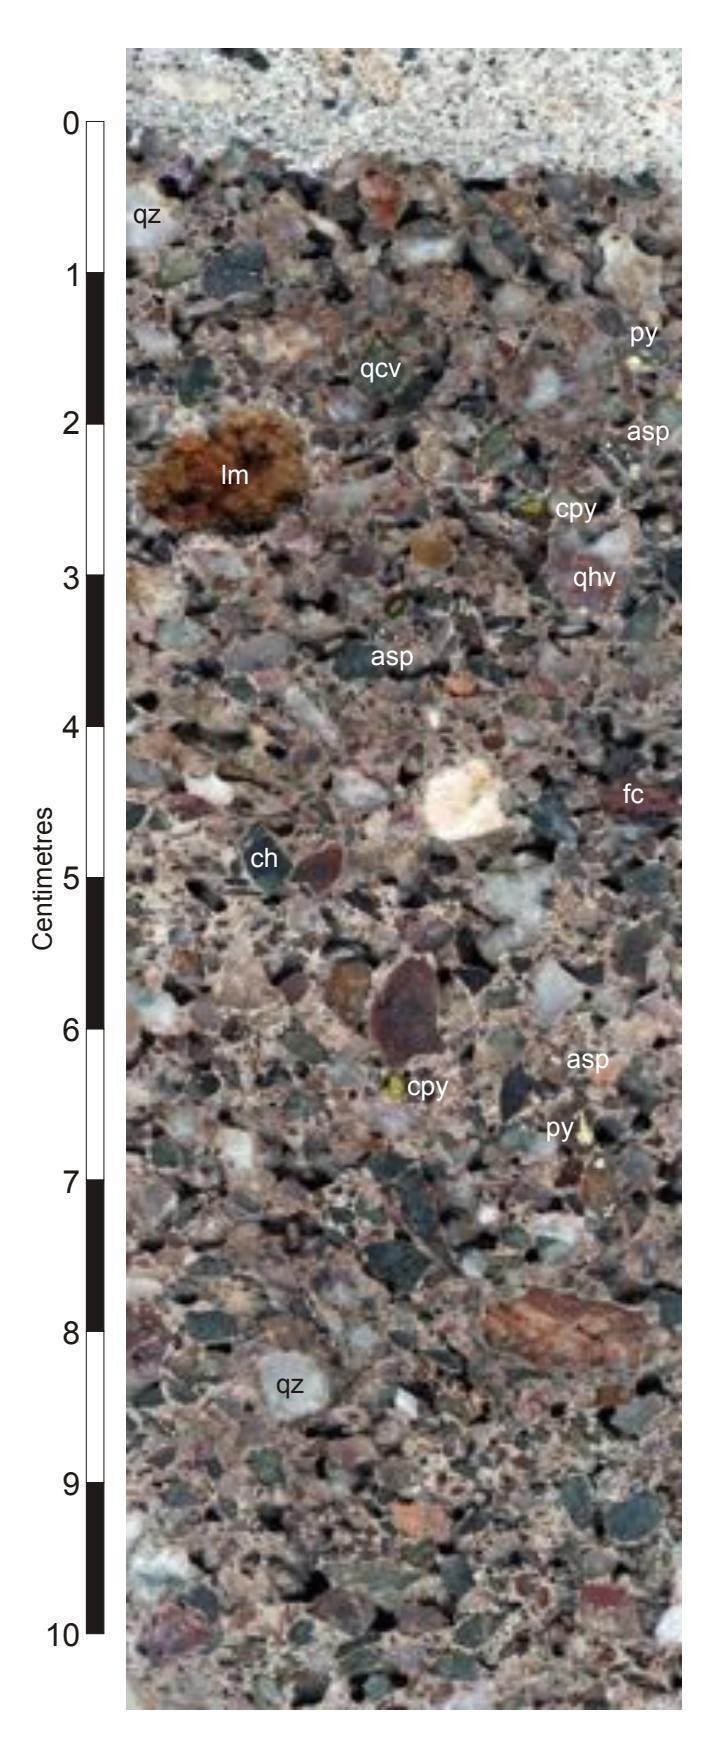
Sulphide-rich mining and ore processing wastes are responsible for most aggregate-related concrete degradation in the Camborne and Redruth areas. This aggregate, from blockwork, is a typical byproduct of the processing of hypothermal, exogranitic tin - copper ores.

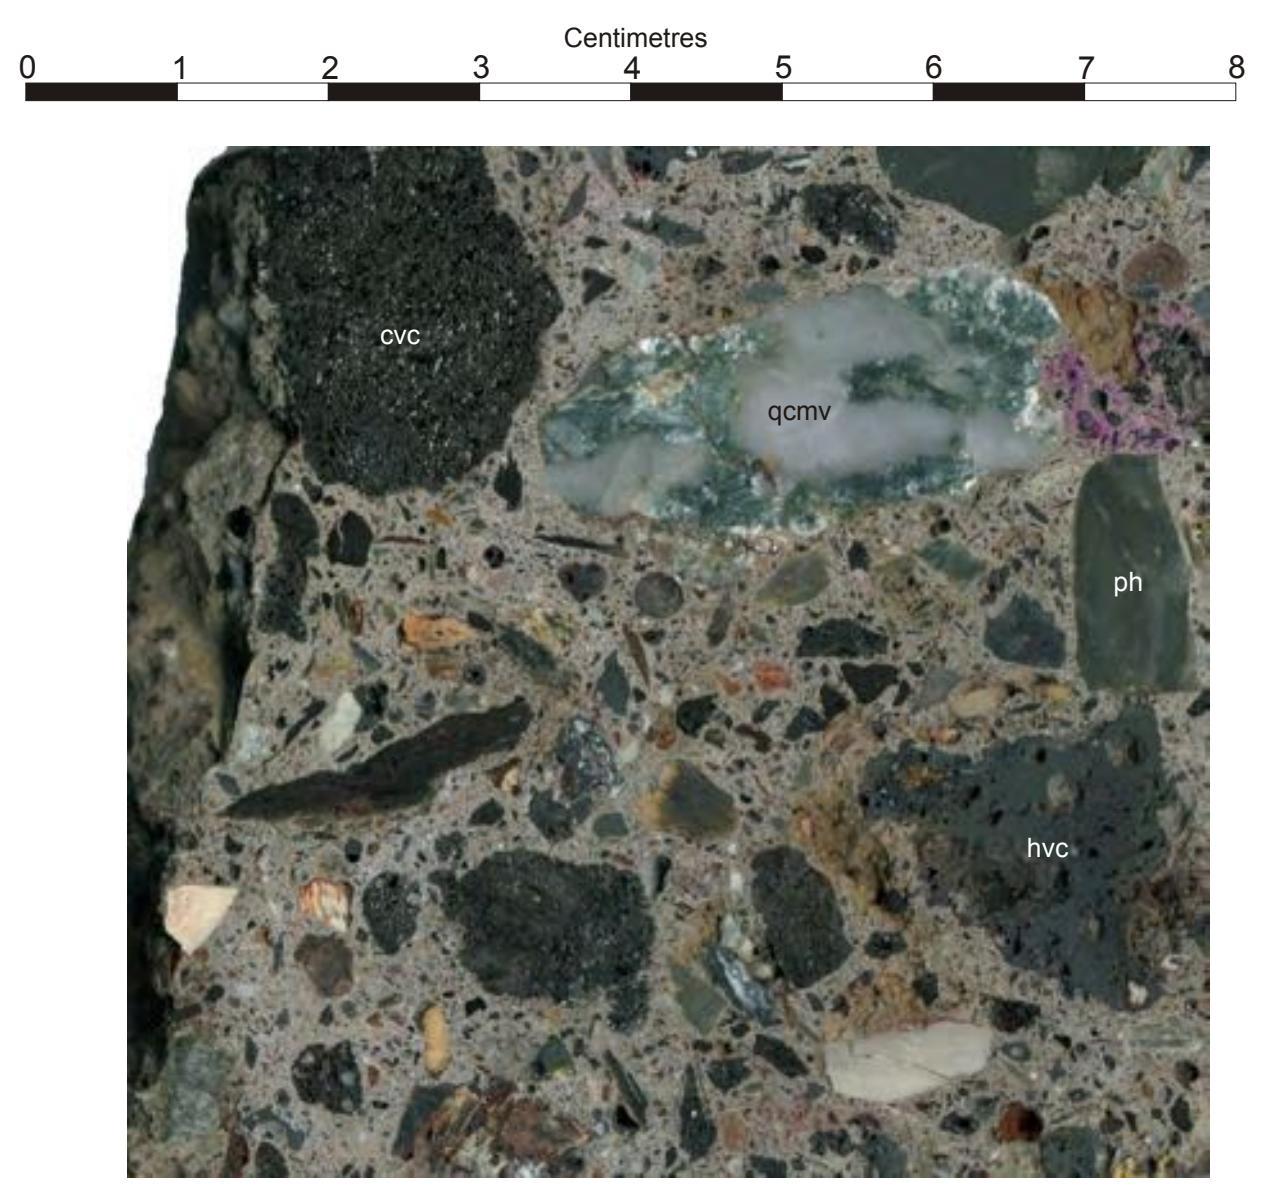
This specimen is from the mass concrete foundations of a house in Goldstithney. Combinations of furnace clinker and complex mining wastes are common in this area. Mine wastes are derived from hypothermal tin - copper mineralisation that occurs on the western and eastern flanks of the Tregonning - Godolphin granite. Mixed aggregates are found occasionally in blockwork though they are much more common in mass concrete. The mine waste has variable and often high sulphide mineral content. In this specimen the furnace clinker aggregate consists of carbonaceous-vesicular clinker (cvc), hyaline and hypohyaline-vesicular clinker (hvc) and small amounts of partly burned coal. The mine waste is lithologically complex and includes quartz - chlorite - muscovite veinstones (qcmv), quartz - chlorite veinstones, vein quartz, fine-grained pelitic hornfels (ph), iron oxides and small amounts of stable silicate minerals among the finer size fractions. Note the iron oxide haloes that partly enclose some veinstone fragments, suggesting that the aggregate has undergone some *in situ* oxidation.

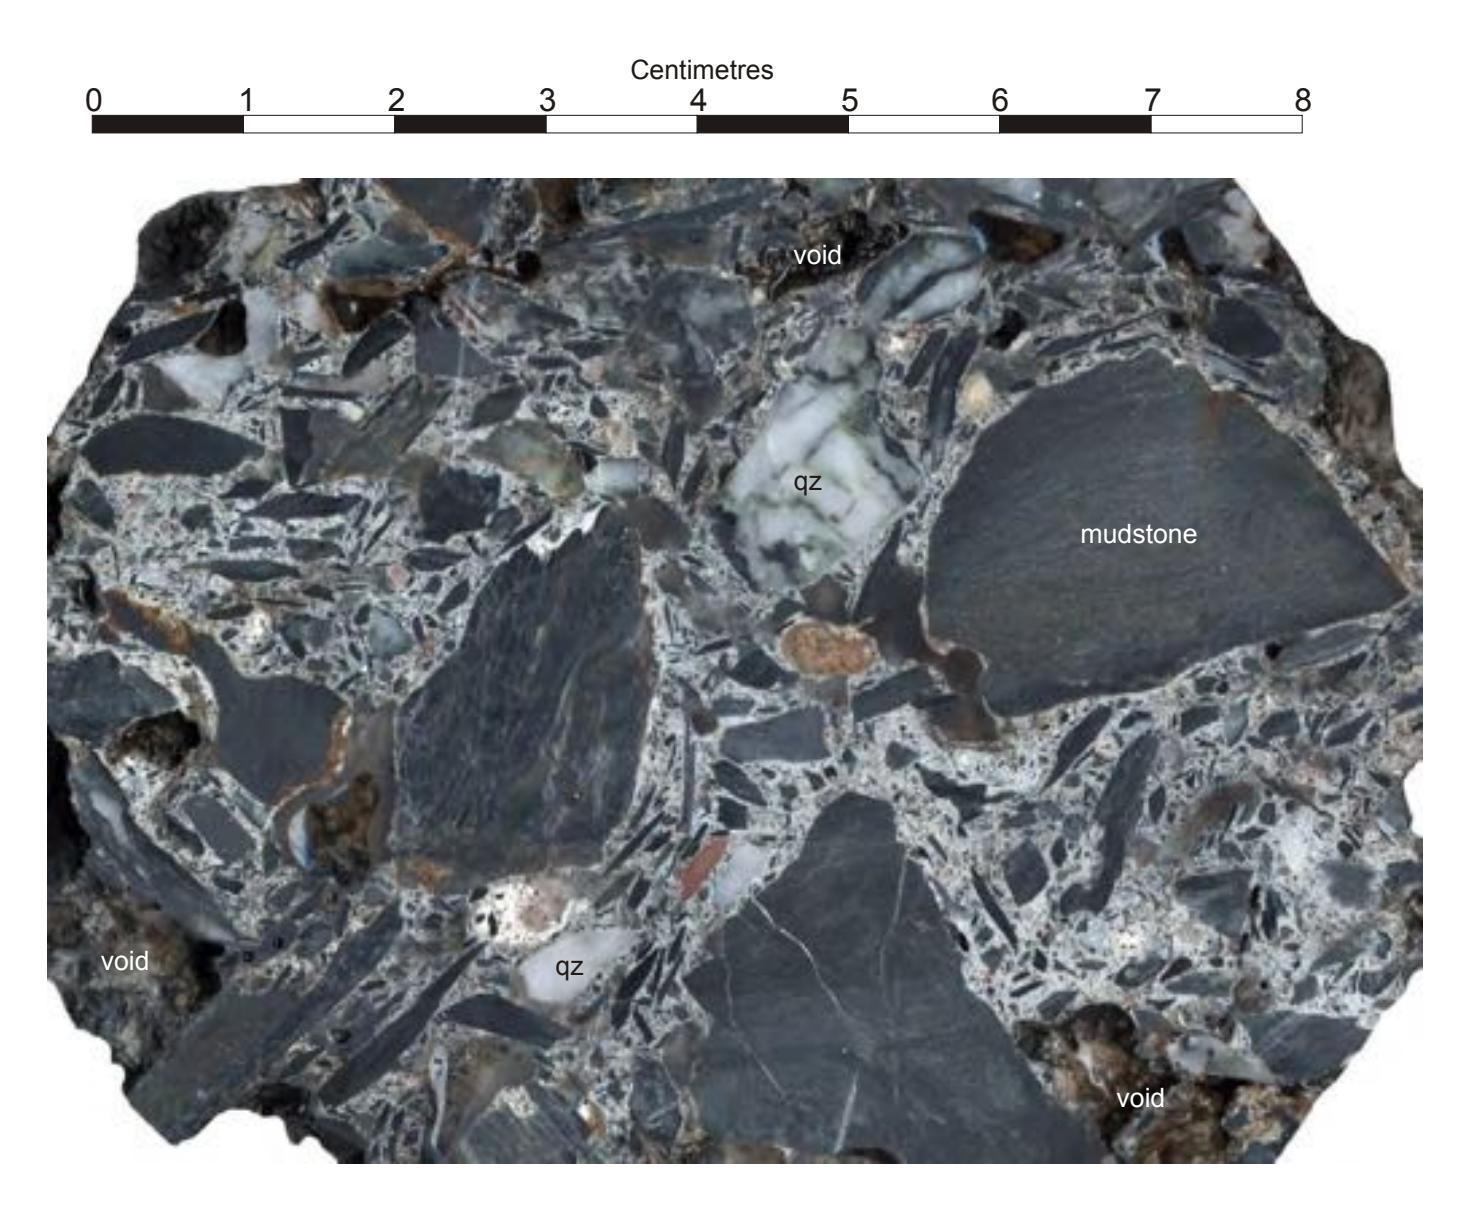
This specimen is from the mass concrete foundations of a house in Truro. The aggregate is probably a pelite-hosted mine waste from the St Day mineralised district though it contains no visible sulphide minerals and the quartz (qz) is probably from syntectonic veins rather than mineralised lodes. The aggregate is only slightly oxidised, there are only occasional, impersistent limonite rims on mudstone fragments and no iron oxide impregnation haloes in the cement. The concrete generally has high cement:aggregate ratio though there are some large, irregular voids that suggest restricted zones of high interconnected porosity.

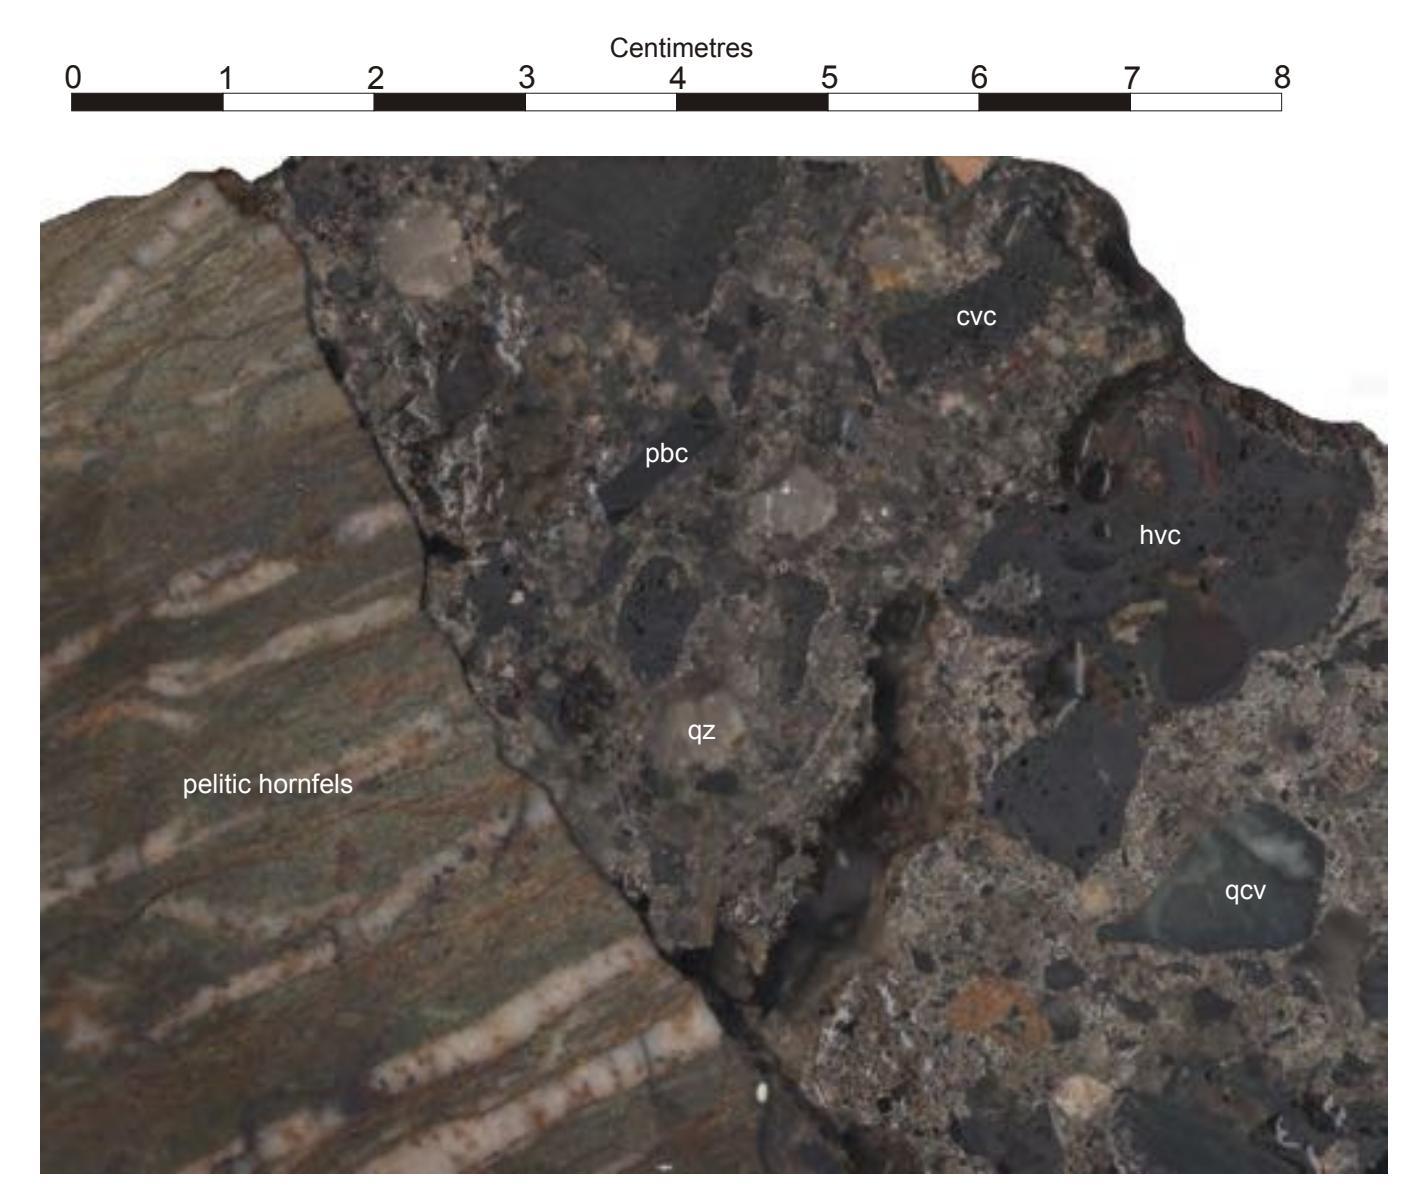
This specimen is from mass concrete foundations of a house in Truro. The coarse aggregate is probably a pelite-dominated mine waste from the St Day mineralised area though it carries only traces of sulphide minerals. The fine aggregate is a mixture of china clay waste and furnace clinker.
