Petroab Ltd, C Edwards Offices, Gweal Pawl, Redruth, Cornwall TR15 3AE, United Kingdom

A compendium of concrete aggregates used in Southwest England

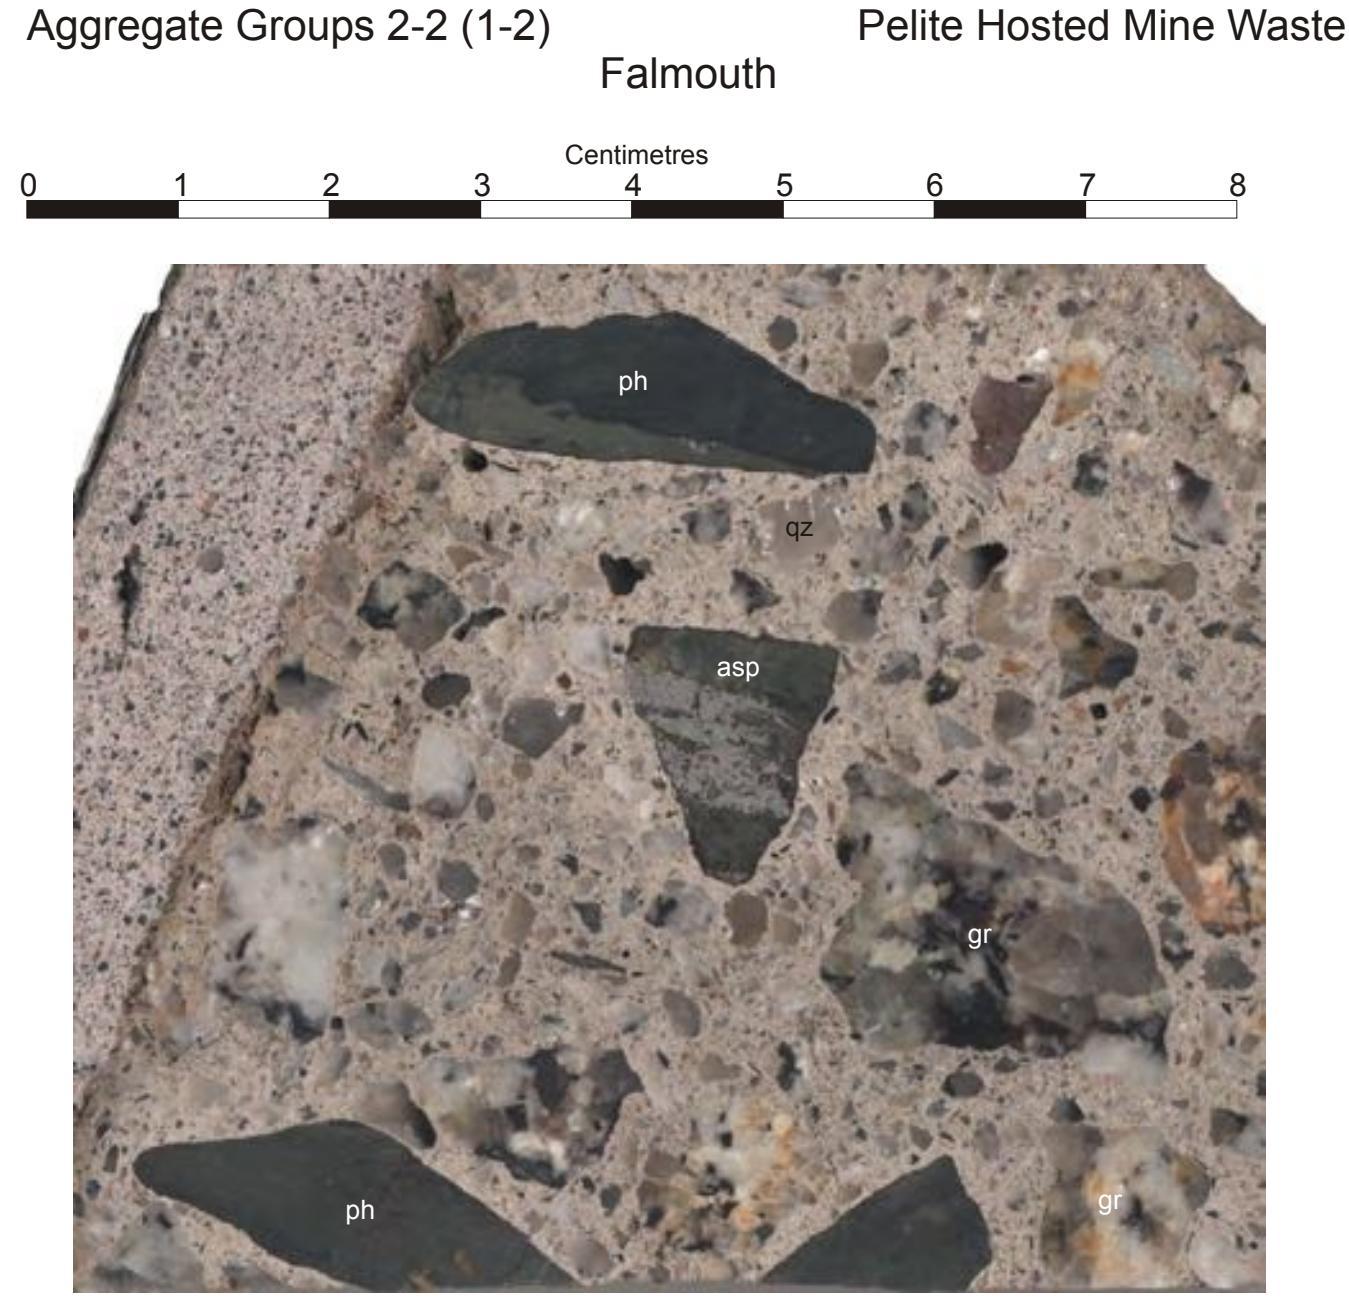
The coarse aggregate in this mass concrete from the foundations of a house in Falmouth is a pelitehosted mine waste. The main components are dark bluish grey pelitic hornfels (ph), quartz chlorite veinstones and vein quartz. Some veinstone fragments may be very rich in sulphide minerals. The veinstone in the middle of the plate is almost half arsenopyrite (asp). Sulphide minerals tend to be concentrated in a small number of widely dispersed aggregate fragments (the "nugget" effect) and the average sulphide mineral content of the concrete may be less than 0.5%. The second aggregate is crushed granite (gr), consisting of large composite fragments and smaller liberated grains of feldspar, quartz (qz) and subordinate muscovite, biotite, chlorite and tourmaline.
